**City of Ypsilanti
Park Restroom Evaluation Study**

OHM # 0094-18-0110
October 10, 2018

Purpose

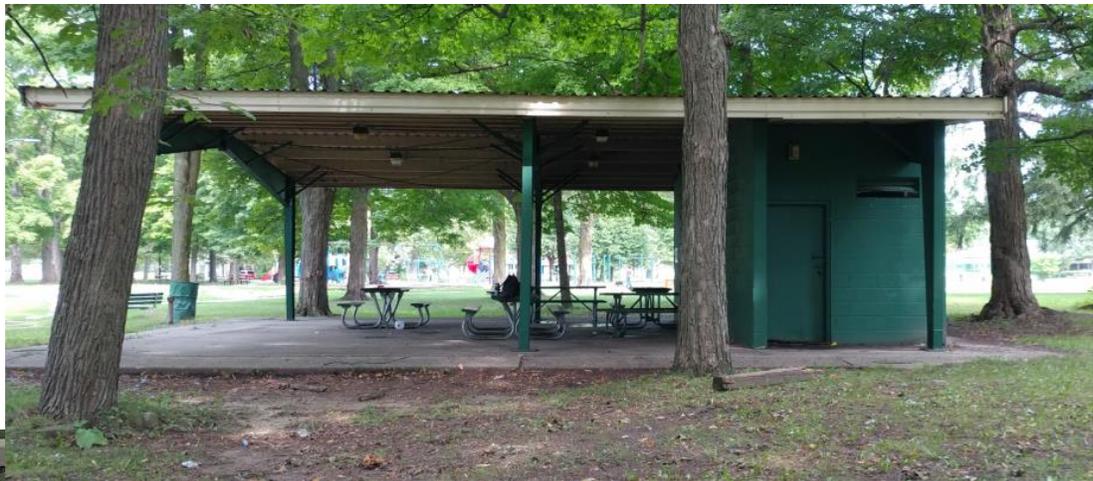
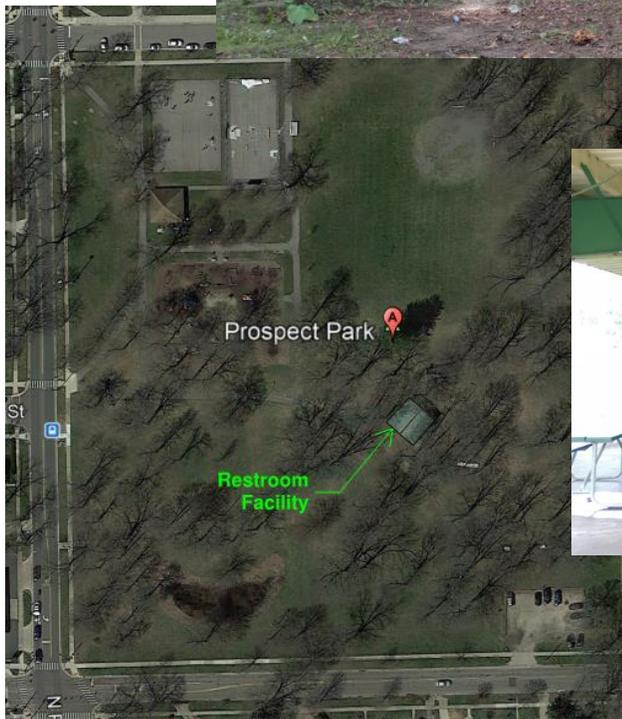
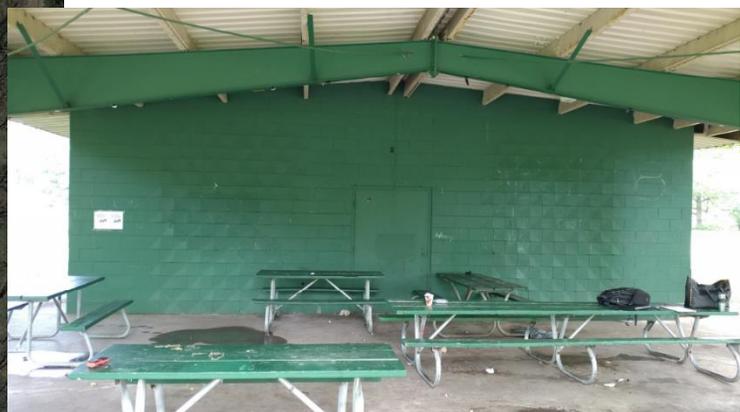
The Prospect Park restroom building is constructed of single-wythe masonry walls, concrete floor slab, and metal roof. The roof extends from the building to cover a concrete slab on grade picnic area adjacent to the building. The building itself consists of two single occupant toilet rooms on either side of a storage area. Each restroom has a louvered opening to allow natural ventilation, and a glass block window for natural light. Restroom fixtures are stainless steel.

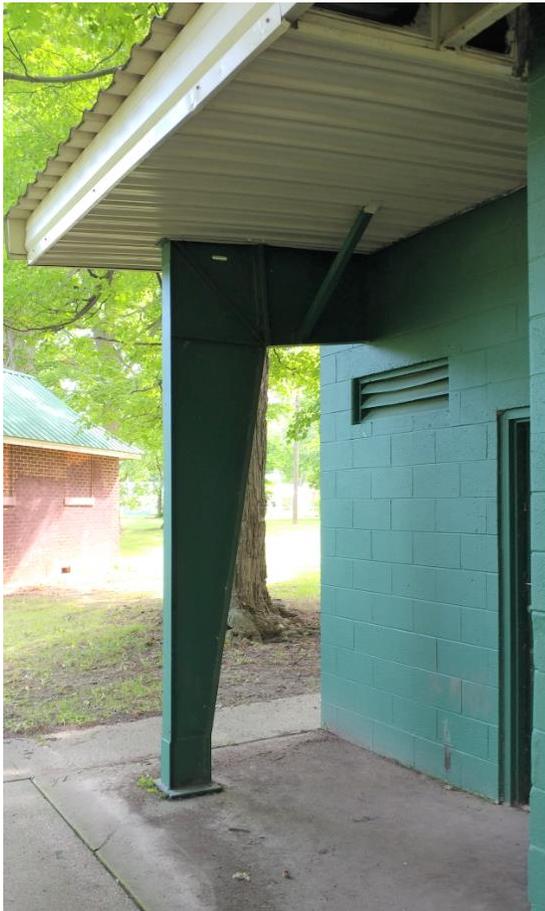
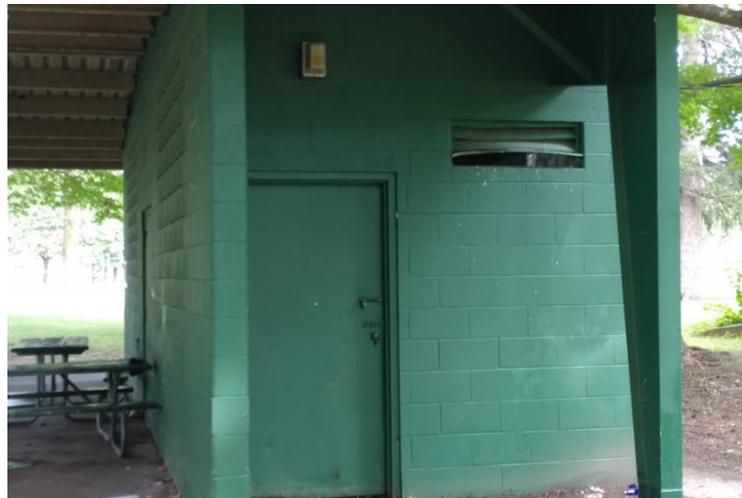
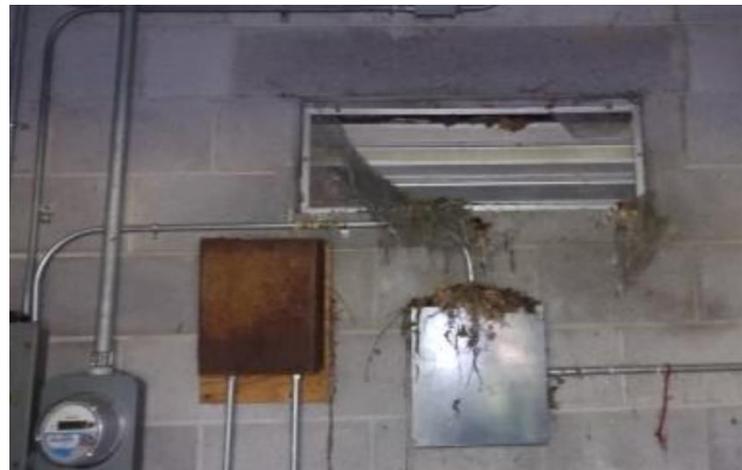
The masonry walls are structurally in good condition but they need to be repainted and coated with a graffiti resistant material. The underside of the roof needs to be repainted also. The paint on the purlins supporting the roof is deteriorating and causing the purlins to rust. The rust needs to be removed from the steel and the purlins need to be repainted. The concrete pad at the picnic area is in acceptable shape. Exterior lighting should be replaced with LED fixtures.

All the hollow metal doors are in poor condition and need to be replaced. The ventilation louvers are bent and damaged and need to be replaced. The glass block windows are missing much of the glazing due to vandalism and should be replaced with a more vandle resistant glazing option.

All restroom fixtures are damaged and need to be replaced, however, the plumbing and electrical infrastructure is in good condition. Interior lighting should be replaced with LED fixtures. The interior plaster walls are in in good condition but need to be repainted and coated with a graffitti resistant material. The concrete floor slab in both of the bathrooms and storage room is in good condition but should be sealed. The plaster ceiling in the bathrooms needs to be repainted.

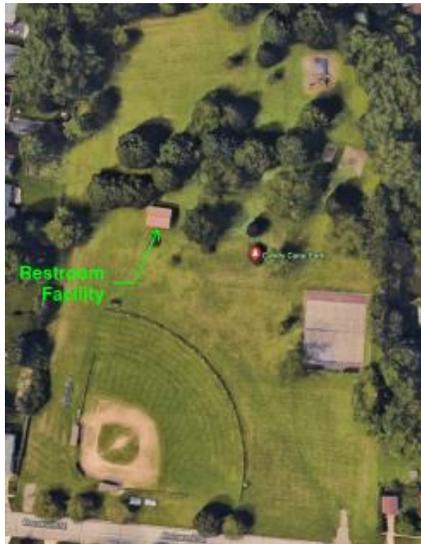
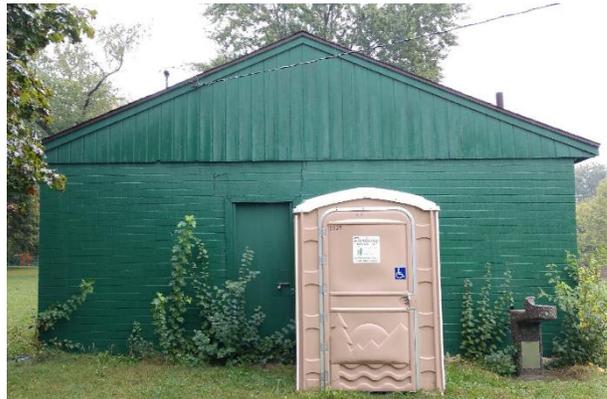
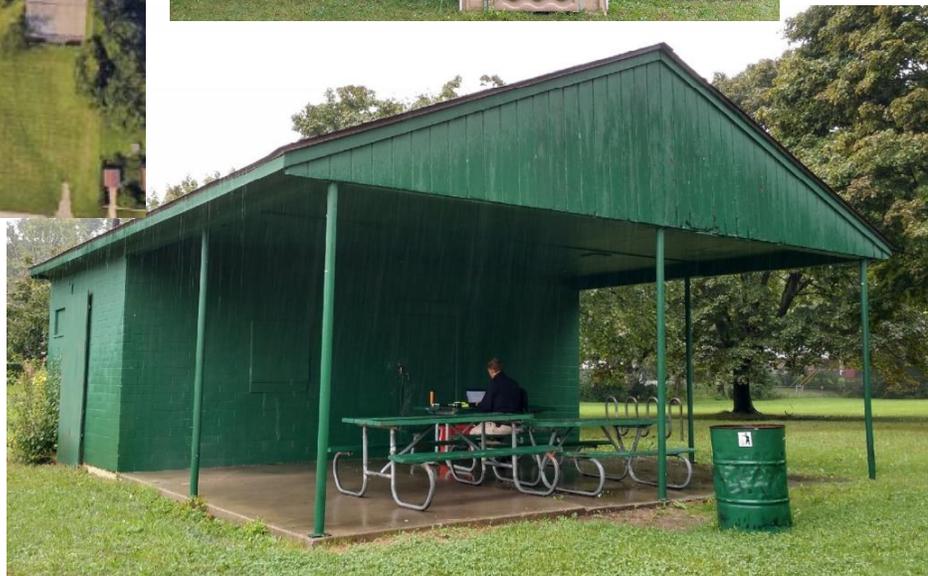
The Candy Cane Park restroom building is constructed of single-wythe masonry walls, concrete floor slab, wood roof trusses, and an asphalt shingle roof. The roof extends from the building to cover a concrete slab on grade in the covered picnic area adjacent to the building. The building itself consists of two single occupant toilet rooms on the far side (west) of the L-shaped storage area that abuts the pavilion.

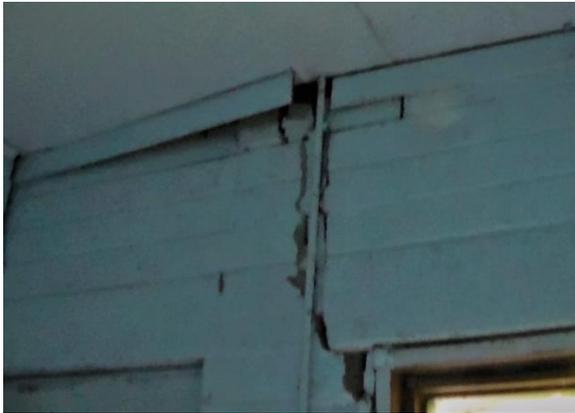
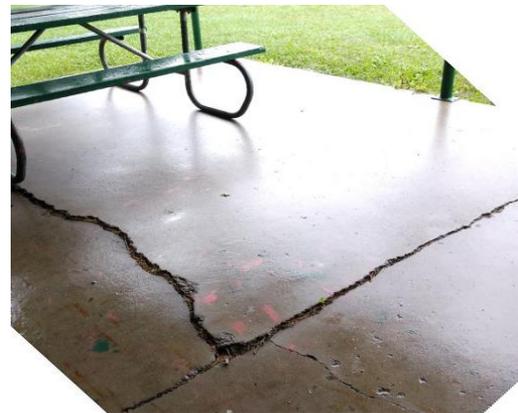
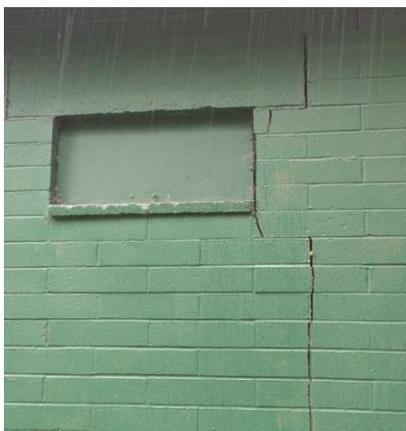
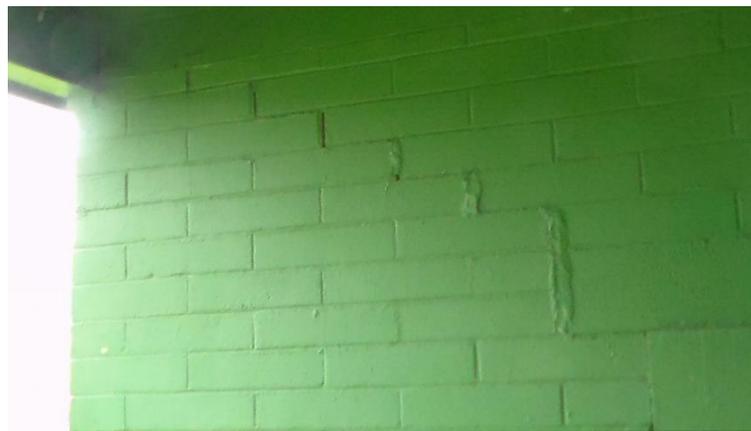
The masonry walls show signs of foundation settlement along the south wall and the south slab in the pavillion area. There are diagonal cracks on the East wall inside the pavillion starting at the top in the Southeast corner extending downward to the North and in the Southwest corner along the south wall. The slab in the pavillion did not have contraction joints when it was poured, and has now formed contraction cracks with the Southeast slab settling on the south edge, thereby lifting up its north edge creating a one inch trip hazard. The masonry wall on the inside of the pavillion (East wall) needs the two diagonal cracks pointed up with mortar and needs to be repainted and coated with a graffiti resistant material. The concrete pad in the picnic area is in marginal shape. If the slab is not removed and replaced, it is recommended to have the trip hazard ground down (15 ft of grinding) and the cracks routed and sealed (65 ft). The masonry around the building has cracks on all sides that need to be routed and pointed, then needs to be repainted and coated with a graffiti resistant material.

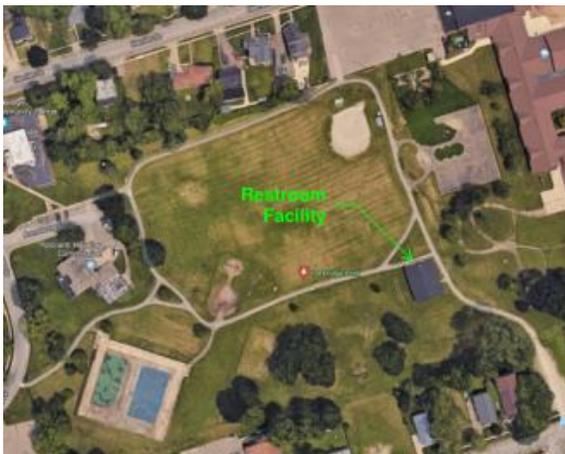
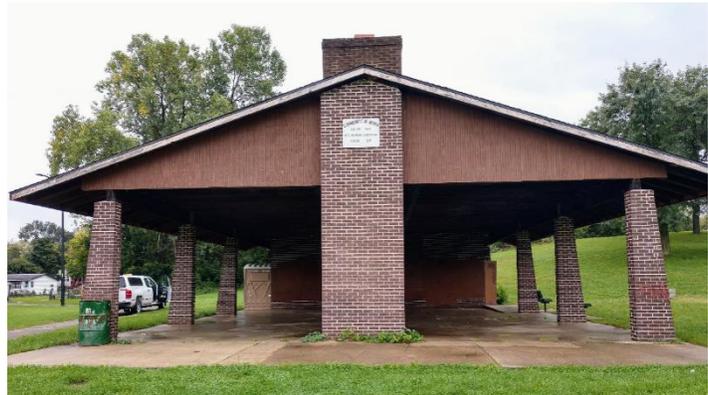
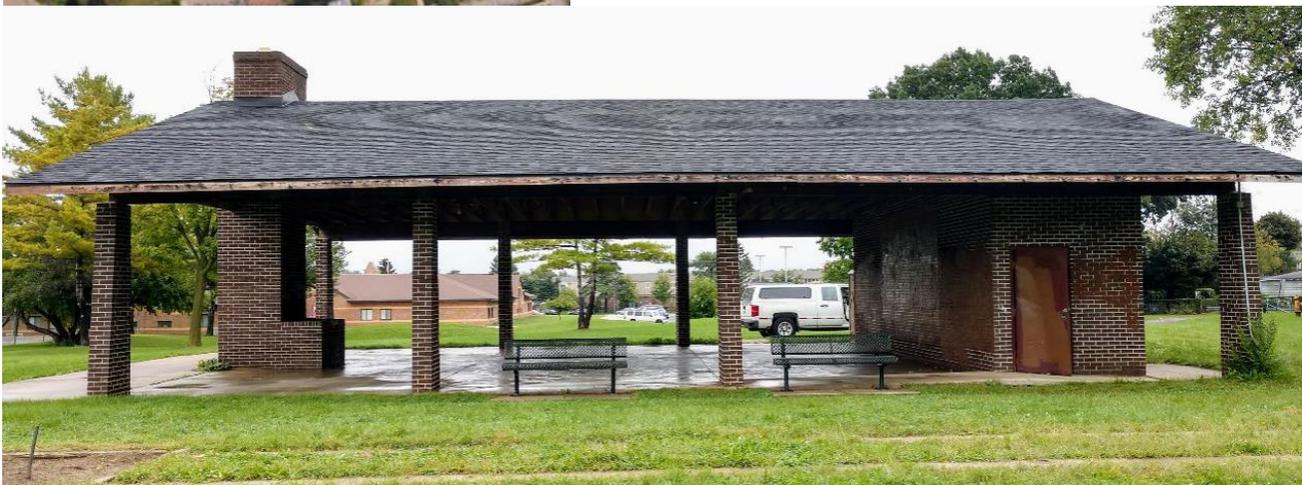
The Parkridge Park restroom building is constructed of CMU walls with brick facade, concrete floor slab, wood roof trusses, and an asphalt shingle roof. The supporting columns have been capped in a brick façade before the column connects to the engineered beams. The roof extends from the building to cover a concrete slab on grade in the covered picnic area adjacent to the building. The building consists of two toilet rooms in the Southeast and Southwest corner of the building and a storage room. There is a utility cavity between the two bathrooms. The two bathrooms and the storage room have 36" steel doors. Each restroom has a glass block window with vent to allow natural light and ventilation. Restroom fixtures are steel. One bathroom consists of a toilet with a partition, sink, paper towel dispenser/garbage container, and urinal. The other bathroom has a sink, a toilet with partition, a plated appurtenance, and paper dispenser/garbage container. The pavilion has a fireplace at the far end.

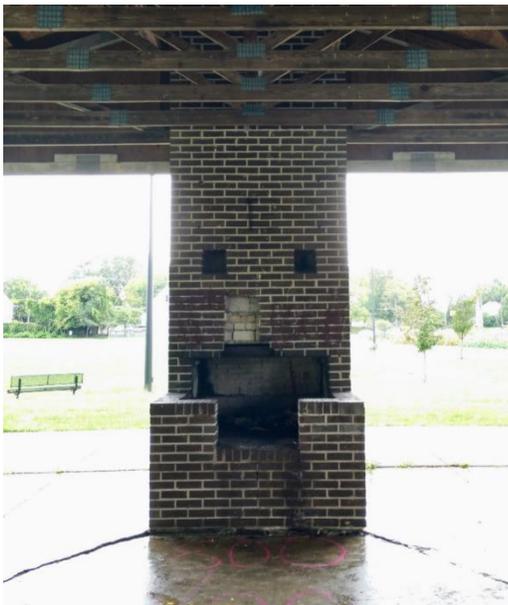
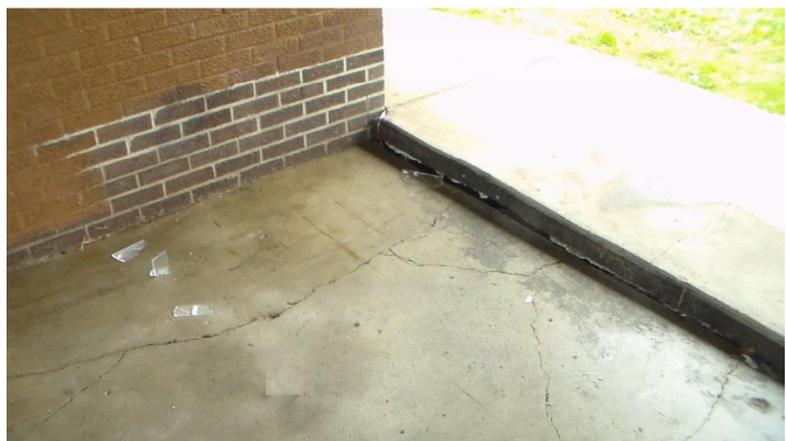
The masonry walls are in good condition when viewed from the inside. There is a gap opening up between the inside CMU, that has a maintenance cavity between the bathrooms for sewer and water, and the outside masonry wall (south). The brick façade is in excellent condition. There is a brick repair needed inside the pavilion on the building wall.

Although the fireplace will require some brick work on the face above the opening, generally the fireplace brick is in good condition outside and inside starting at the corbel working its way up to chimney. In the body of the firebox, below the corbel, pointing up needs to occur. The flue appears to have at least one cracked liner piece, however, its joint is tight. Not all of the flue is accessible for inspection and will need to be carefully televised to determine the repairs necessary. The fireplace should be inspected by an expert for recommended repairs. The fireplace flue should have a cap installed.

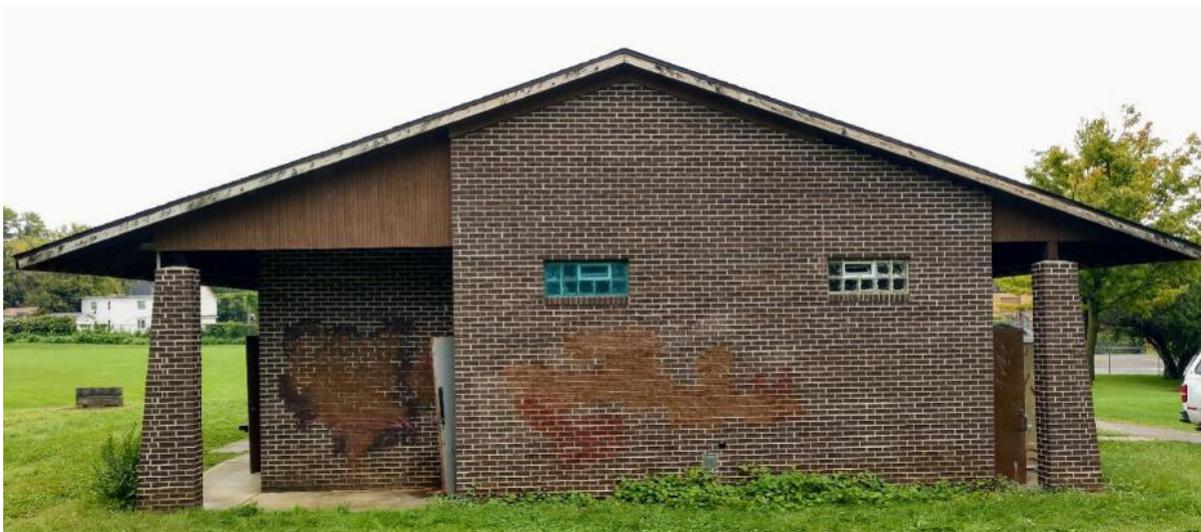
All restroom fixtures need to be assessed as they may be salvagable with new piping and appurtanances (sloan valve, faucet, etc). The stall walls need to be replaced with something more heavy duty as the old ones are loose and are coming out of the wall and floor. The mirrors (one of which is the access to the plumbing and electrical piping cavity), the paper towel holders/garbage cans, and urinal all need replacement. In the East bathroom, there appears to be a plated spot where a urinal used to be, with a push button above the plate.

The plumbing and electrical infrastructure appears to be in decent condition. The shut off gate valve on the 2" plastic water service coming through the floor in the service cavity needs to be replaced. It is recommended that all the galvanized piping be removed before and after the meter horn, replaced with copper, and new ball valves be installed. There appears to be Studer type vents on the plumbing inside the wall cavity that have had the tops removed. These need to be assessed more closely and possibly repaired. The electric panel on the inside of the storage room needs assessment by an electrician, however, it appears to be in working order. Some of it's wiring may need tidying up and a new face put on it that can be locked. There is a large feed to an external stage/entertainment area by the baseball diamond, per the DPW.

Interior lights (3) in the bathrooms and storage should be replaced with LED fixtures. All lights should be put on countdown timers. The interior masonry walls are in good condition, but need to be repainted and coated with a graffiti resistant material. The concrete floor slab in both of the bathrooms and storage room is in good condition but should be sealed with a floor paint. The plywood ceilings in the bathrooms need to be repainted. The floor drains, the toilet, urinal, and sink should be augered and televised to insure they are open and functional. Televising could verify if the sanitary outside the building is in good conditon. YCUA should be coordinated with to establish if the sewer lead in the ROW is in usable condition.

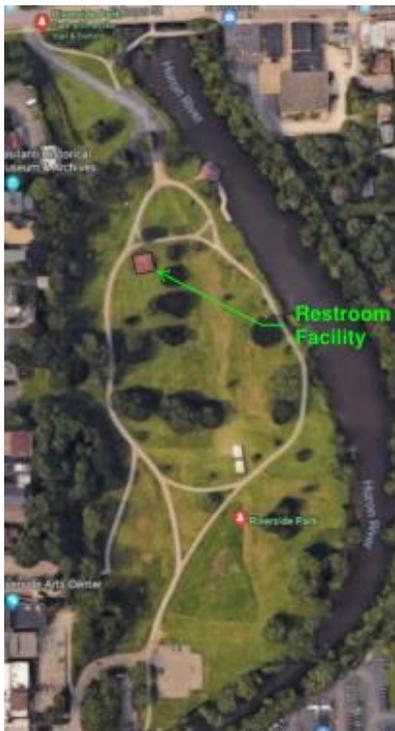
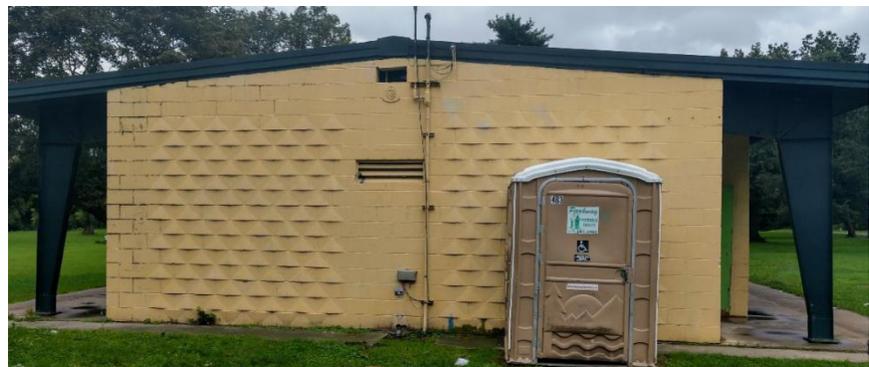
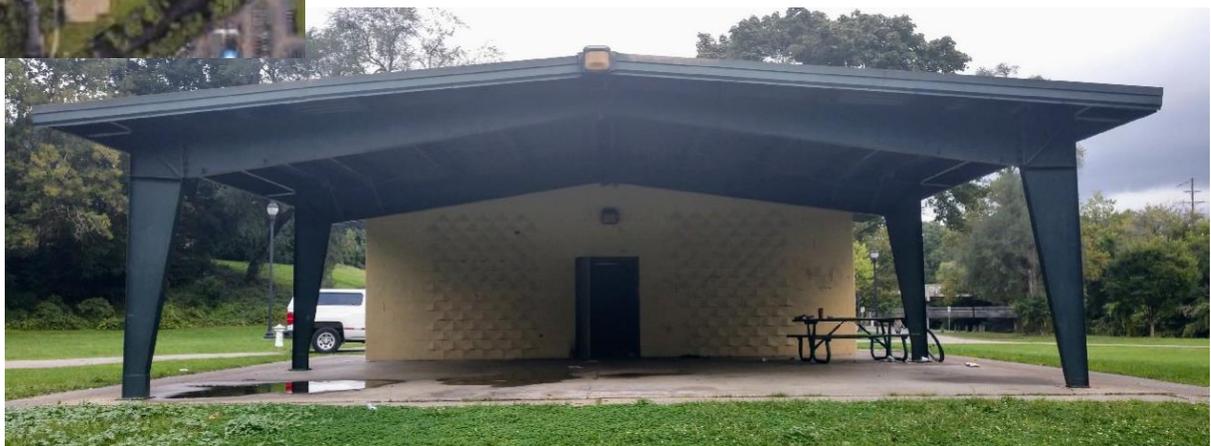
The Riverside Park restroom building is constructed of single-wythe masonry walls, concrete floor slab, and metal roof. The roof extends from the building to cover a concrete slab on grade picnic area adjacent to the building. The building itself consists of two toilet rooms on the north side of a storage area. Each restroom has a louvered opening to allow natural ventilation. Restroom fixtures were likely ceramic.

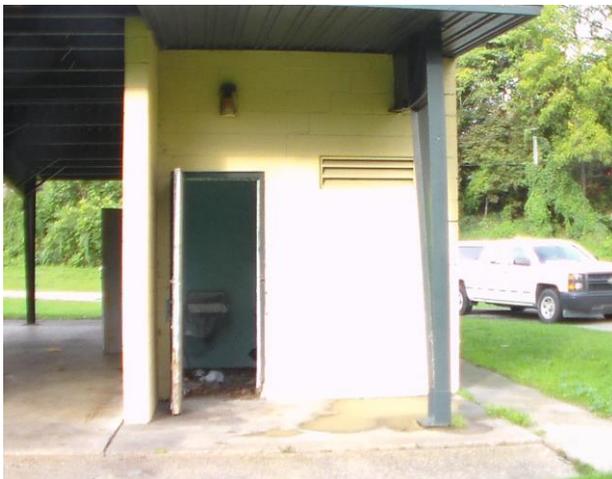
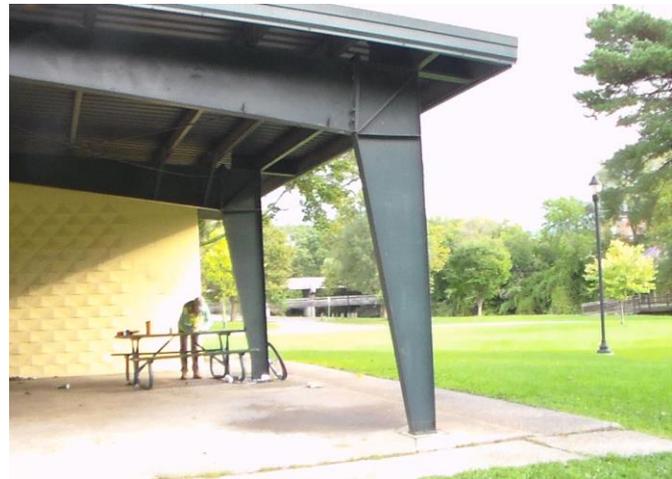
The masonry walls are structurally in good condition but they need to be repainted and coated with a graffiti resistant material. The underside of the roof needs to be repainted also. In some areas the paint on the metal posts supporting the roof is deteriorating and causing rust. The rust needs to be removed from the steel and the posts need to be spot painted, at a minimum.

The concrete pad at the picnic area is in acceptable shape. It is recommended that the joints be blown out and sealed, and the cracks routed and sealed. There is a 3' wide concrete perimeter slab around the building and pavillion that has settled and shifted in places. It could be removed and not replaced or removed and replaced. There needs to be a hard surface installed from the bike path to the pavillion. Exterior lighting should be replaced with LED fixtures. There is a block missing on the north wall for the photo-eye sensor which is located inside the storage room. This could be moved outside and blocked up, or insect screen installed over the opening.

All the hollow metal doors, hinges, and frames are in poor condition and need to be replaced. The bathroom doors are not 3' wide and need to be opened up for ADA access. The ventilation louvers are either damaged or missing, and need to be replaced. The insect screening in many places is damaged and needs to be replaced in the following places – the louvered ventilation, steel beams for access to ventilation above the bathroom ceilings, inside the storage room to the outside, and to the ventilation cavity above the bathroom ceilings. Glass block windows for natural light would be a valuable addition to the bathrooms.

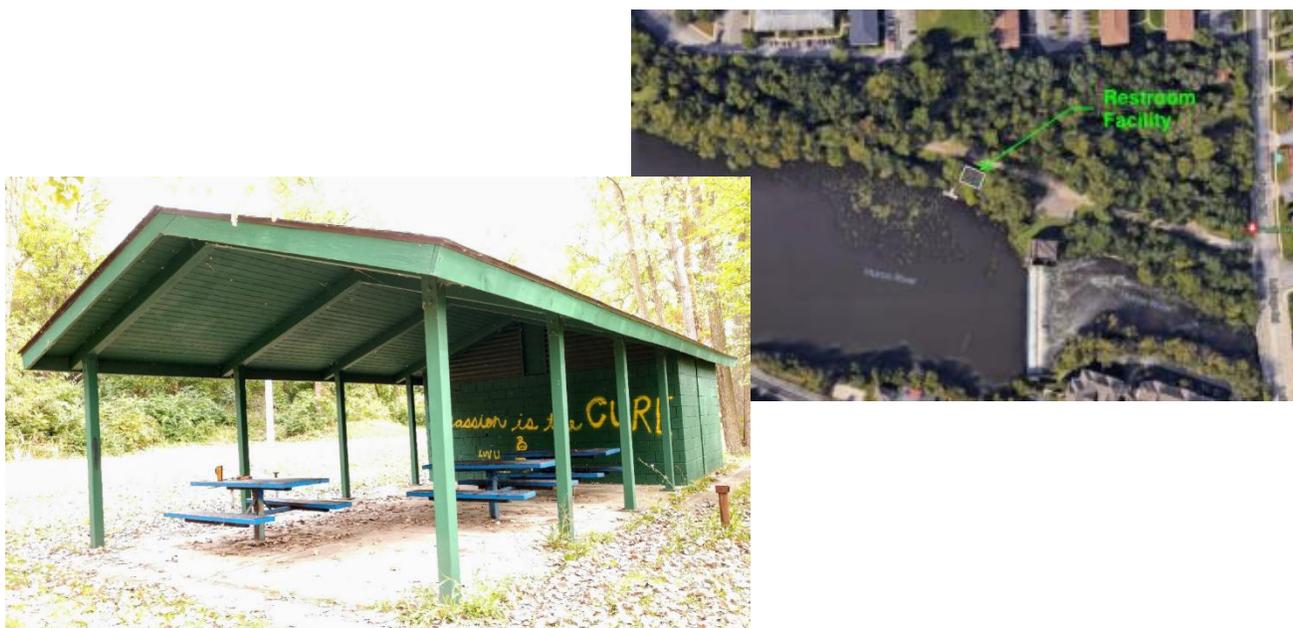
The Peninsular Park restroom building is constructed of single-wythe masonry walls, concrete floor slab, steel frame supports and steel beams, and a tongue and groove roof with asphalt shingles. The roof extends from the building to cover a concrete slab on grade picnic area adjacent to the building. The roof appears to have been redone in the last couple of years and a patch completed in the tongue and groove sheathing. The building itself consists of two single occupant toilet rooms. Each restroom has a louvered opening on two sides to allow natural ventilation. Restroom fixtures are ceramic. The fixtures have been carefully winterized with the traps blown out and the sloan valves disassembled.

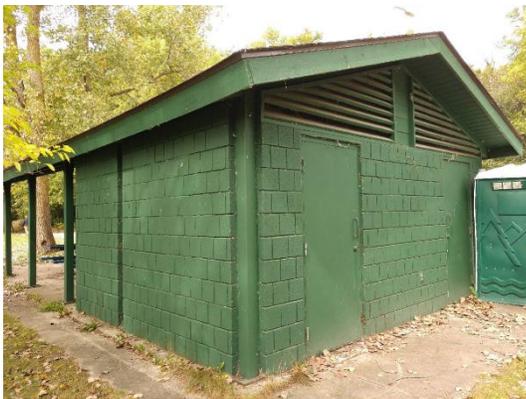
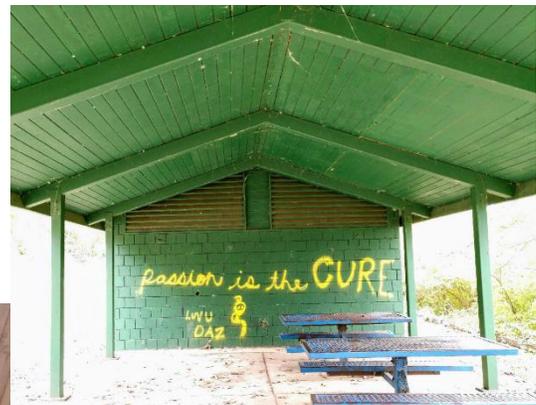
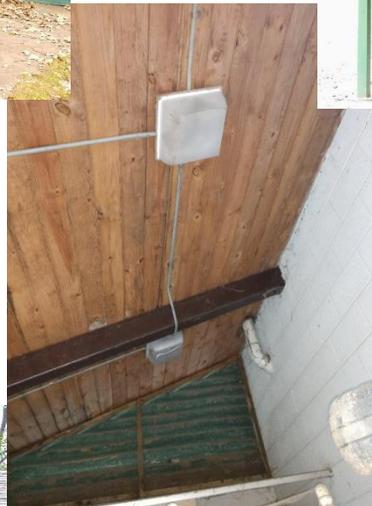
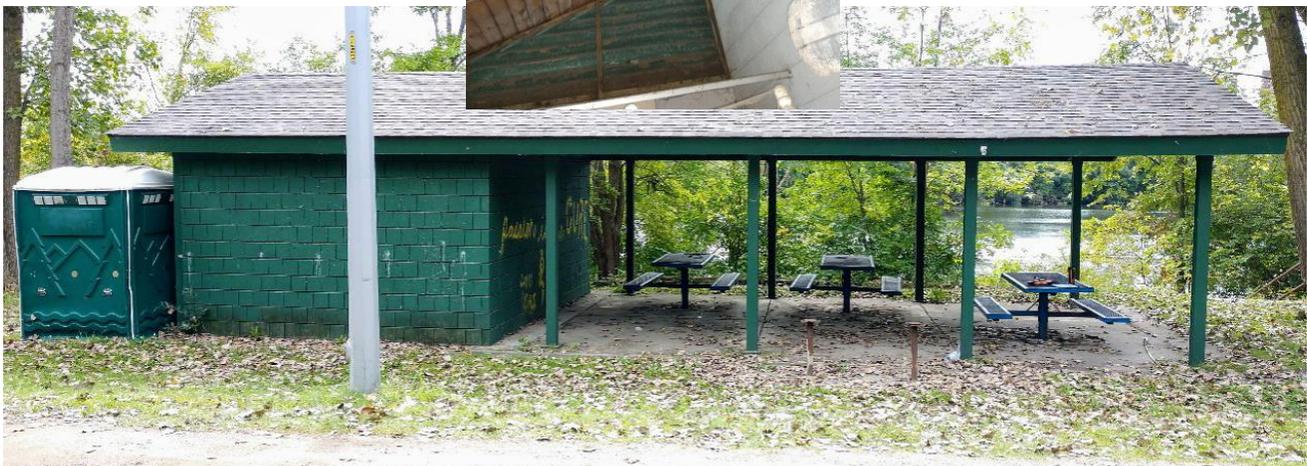
The masonry walls are structurally in good condition but need to be repainted with a graffiti resistant material. The underside of the roof in the pavillion needs to be repainted. The paint on the steel frame supports is deteriorating in a few areas, causing the supports to rust. The spot rust needs to be removed from the steel and repainted with a graffiti resistant paint. The concrete pad at the picnic area is in acceptable shape. The joints should be sealed with a polyurethane sealer. Exterior lighting should be replaced with LED fixtures. The plastic coated steel picnic tables are in decent conditon, however, rust removal and painting is required. The interior floor in both bathrooms needs to be sealed.

Both hollow metal doors are in poor condition and need to be replaced along with the hinges and frame. The wooden ventilation louvers need to be sanded and painted, or replaced. The insect screens are intact, however, to address the louvers, they will need to be removed and thus should be replaced. Glass block

windows should be added to the walls for natural light. The stall dividers either need to be replaced or painted with graffiti resistant paint.

All restroom fixtures are antiquated, however, the plumbing and electrical infrastructure appears to be in good condition. The sloan valves, water supply lines, and fixtures should be replaced. It's possible that the ceramic fixtures could be reused and replumbed. The interior masonry walls are in in good condition, but need to be repainted and coated with a graffiti resistant material. The concrete floor slab in both of the bathrooms and storage room is in good condition but should be sealed. The original wood tongue and groove ceiling in the bathrooms needs to be painted.

Interior lighting should be replaced with LED fixtures. The electrical wiring needs to be assessed by an electrician, and the switches updated. The electrical panels need to be locking boxes.

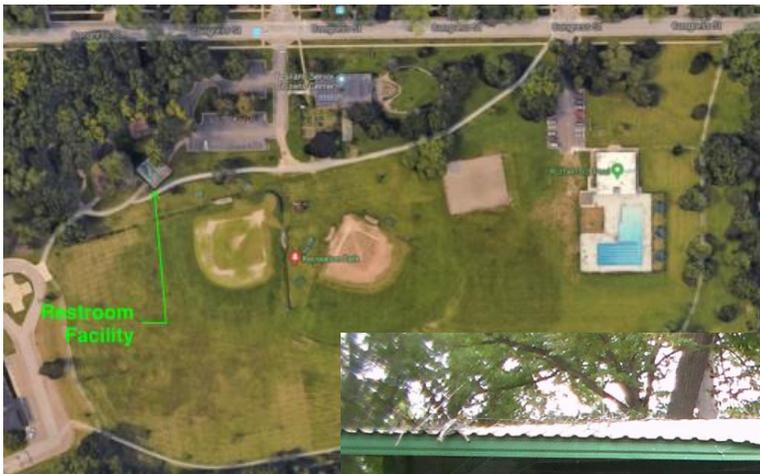
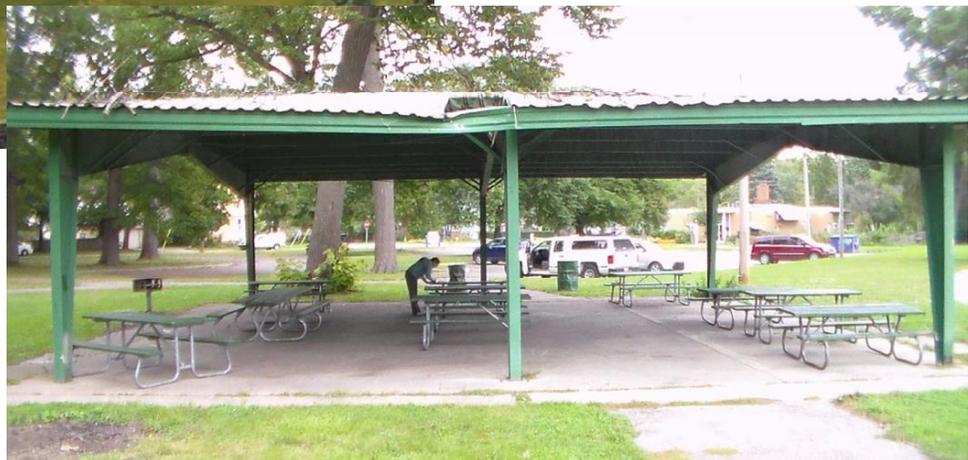
Recreation Park does not currently have a restroom building. The existing covered picnic area is constructed of a concrete floor slab, metal columns and beams, and a metal roof. The roof has been damaged, likely by a tree. The roof covers a concrete slab on grade with picnic tables. It appears there used to be a building, based on evidence on the concrete slab. There are signs of walls that were removed, and utilities coming up through the floor. It looks as if there were two single occupant toilet rooms on either side of a storage or utility area. At this time all that remains are the floor drains (3), the toilet drops (4), the sink drops inside walls (2), and what is likely a sanitary clean out headed for Congress Street.

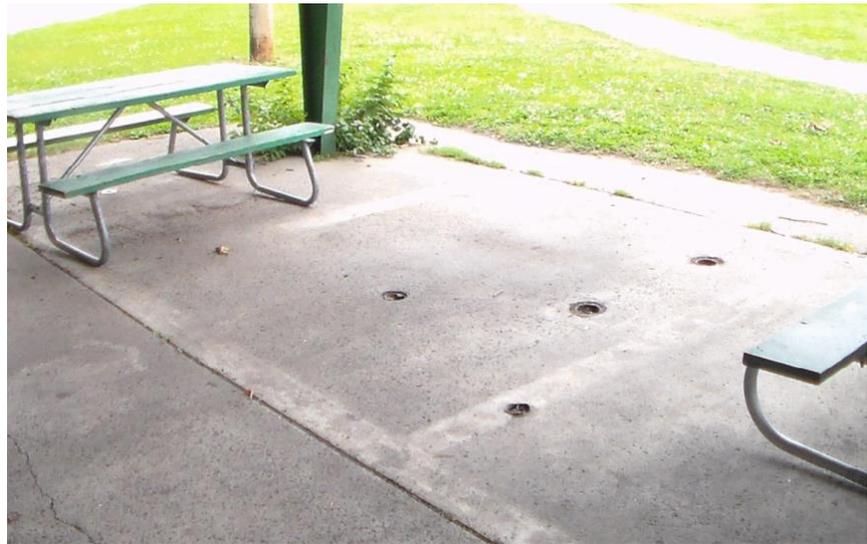
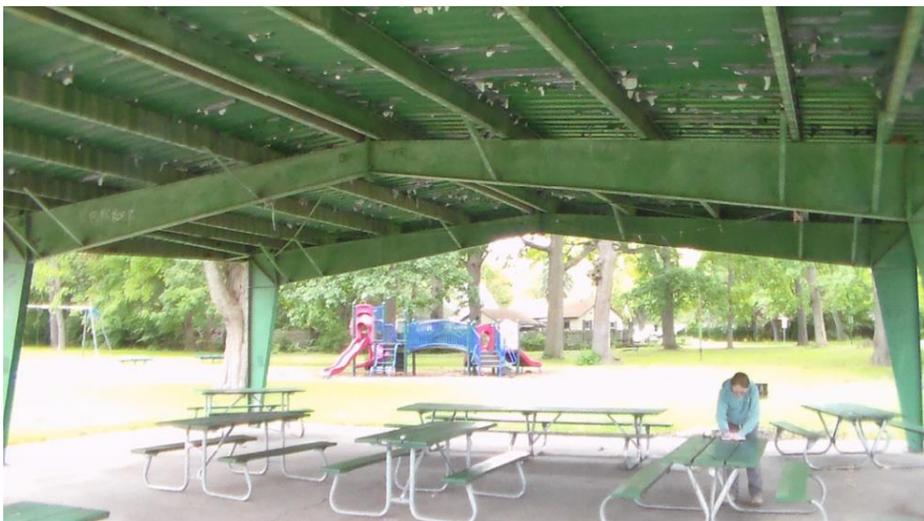
The paint on the roof (top and bottom), columns, and beams is flaking and rust is beginning to damage the steel. There are holes caused by rust at the base of the columns. The roof appears to have been damaged by a tree. Two roof support beams, four roof panels, and one angle support have been damaged. The rust needs to be removed from the steel, the holes will have to be soldered with plates, and the structure needs to be repainted. Those areas that are reachable need to have graffiti resistant paint. There are two cross members that are loose and need to be tightened or likely replaced if rusted through. One half of the

structure does not have cross member support, which will need to be installed. One angle brace is bent and should be repaired and reinforced. The concrete pad within the picnic area is in acceptable shape and will need the joints sealed. It appears the bathrooms were removed before the steel roof was put up as the roof does not have a ventilation port.

It is recommended that this site have a prefabricated bathroom unit installed. It will need the sanitary line cleaned and televised, and the sanitary relocated to the new building pad. The water service will need to be located and installed into the building pad, and ADA access provided. The prefabricated building could be located next to the existing structure, as it likely could not be installed within the structure. The drains in the current structure should be abandoned or removed if a new slab is poured in those areas.
