Salt Barn Structural Evaluation

City of Ypsilanti Public Works Yard
14 West Forest Avenue
Ypsilanti, MI 4897

Date: 31 May 2023

Prepared By: Adam Wagner, P.E.
Wagner Engineering, LLC
Order Number: 2023-071

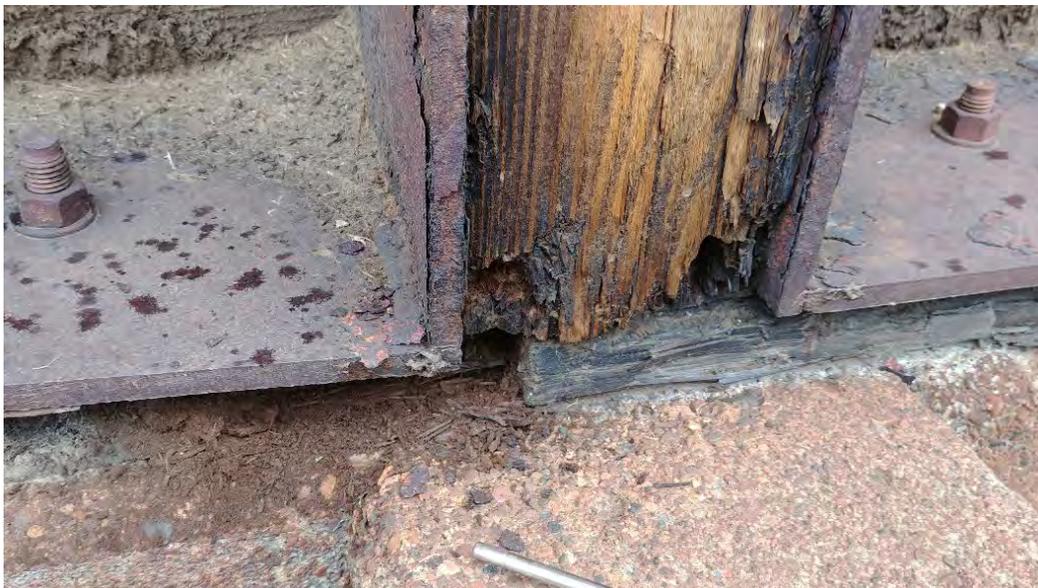
The structure is racking to the west by about 2" over a 4' length, or about 2.4 degrees. The west wall framing has the most deterioration. Nearly all the posts ends and sill is rotten as shown in Figure 1.

Figure 1: Typical Post End and Sill Plate Rot Damage

Additionally, the salt creates a highly corrosive environment for both the wood framing and all ferric based fasteners and connectors. All the deterioration on the west wall framing I attribute to the salt pile against the wall mixing with precipitation.

Timber Column Shoring: Add 4' lengths of pressure treated 2x10 shoring on both sides of any rotted timber columns like the previous repairs done to the east wall. The west wall should be the primary focus since nearly every column is rotted. In addition, replace any rotted sill plate at the column locations.

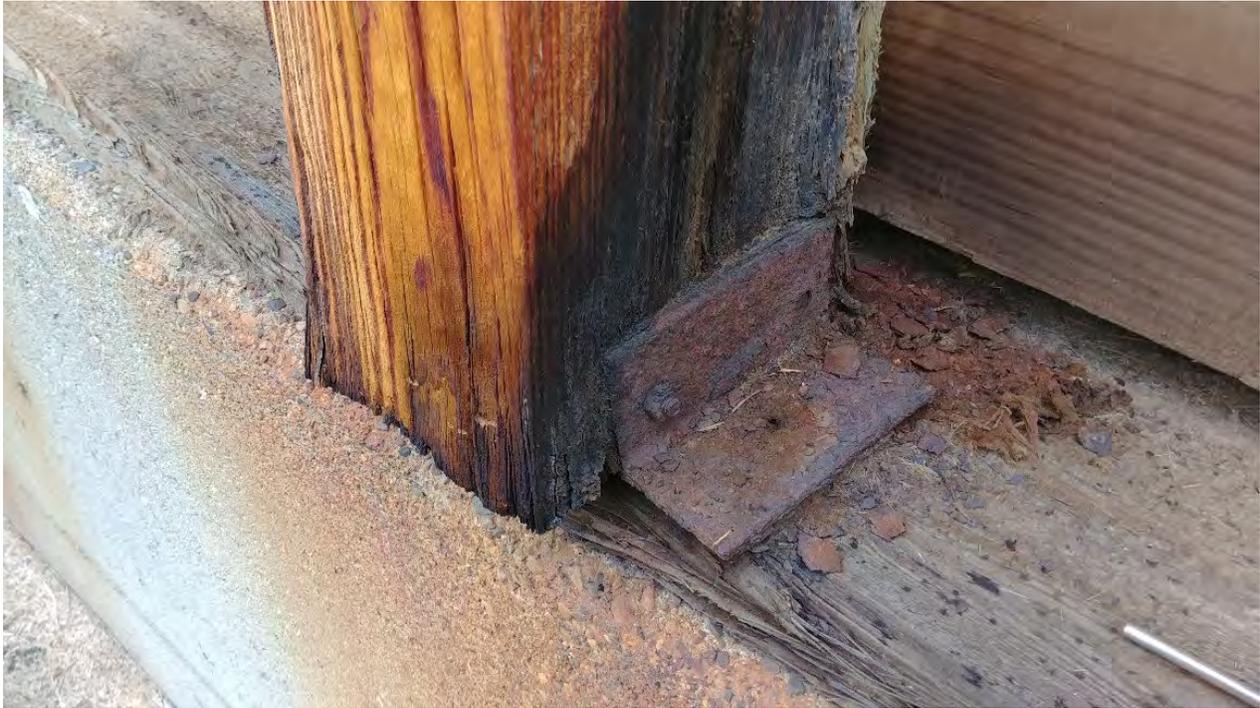
Additionally, most of the steel angles and fasteners have corroded completely and are no longer providing any fastening power between the post and the foundation. Figure 2 shows a typical state of the steel angle brackets and fasteners on the west wall.

Figure 2: Steel Angle and Bolt Corrosion

Steel Bracket Replacement: Replace any corroded steel angle brackets and refasten to the concrete foundation at any point, but specifically along the west wall.

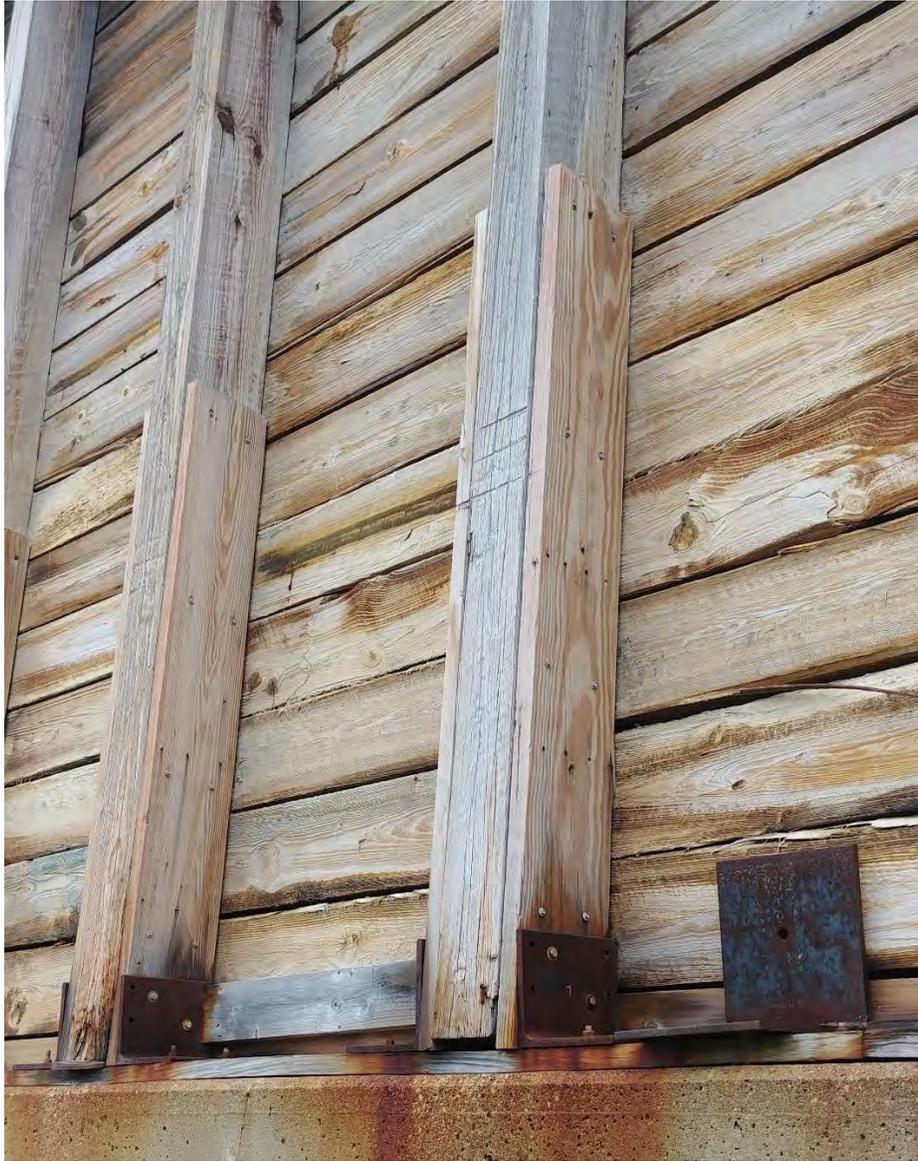
The east, south, and north walls have minimal rot and bracket deterioration. The east wall has evidence of previous repairs; namely some of the original brackets have been replaced and several of the posts have been shored with new timber fastened to the original posts as shown in Figure 3.

Figure 3: Previous Repairs to Columns and Replacement Bracket

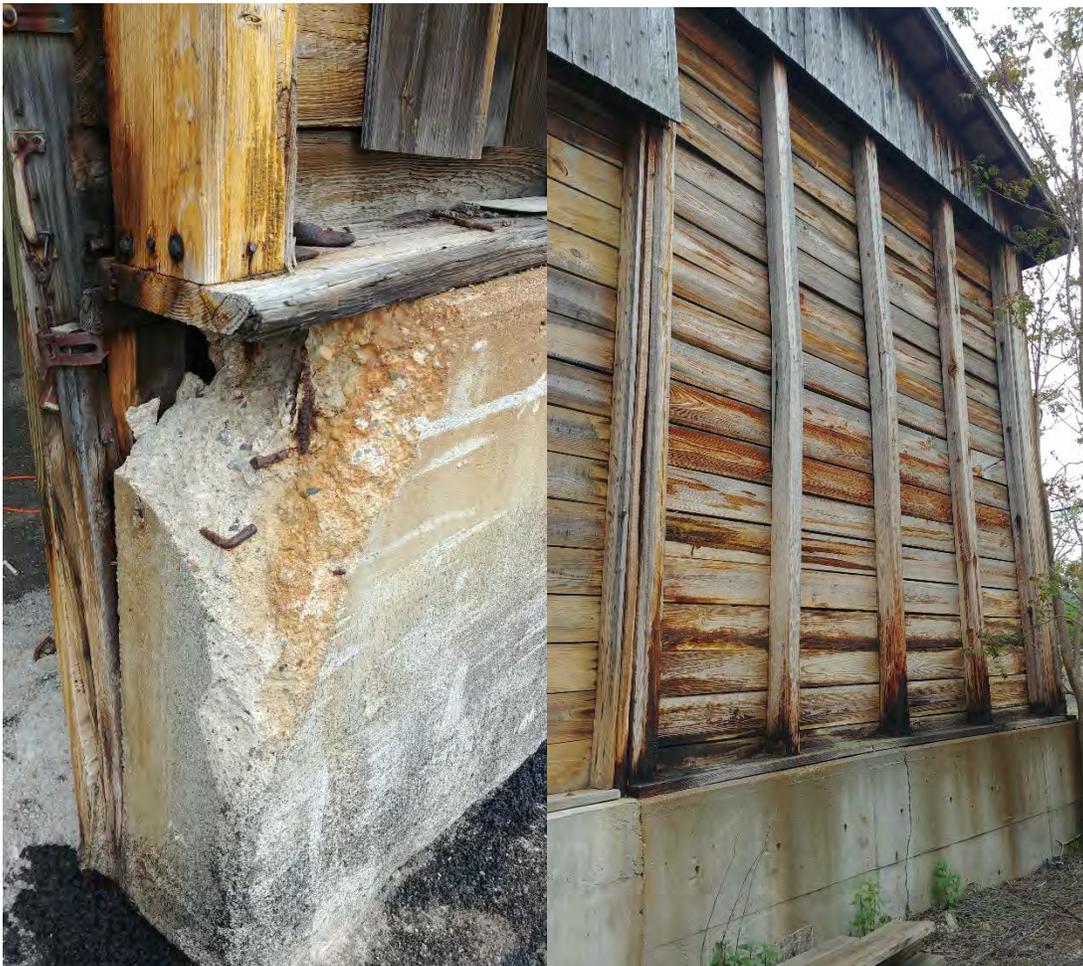
There are two wall locations where vehicle strikes have damaged the structure: at the east side of the vehicle main entrance and at the northwest corner of the barn. The entrance damage is to the edge of the concrete stem wall, which has exposed the interior steel reinforcing. The damage to the north wall has buckled two of the timber columns. Figure 4 shows the vehicle damage at the two locations.

Figure 4: Vehicle Strike Damage to the Entrance and North Wall

Equipment/Vehicle Strike Preventive Controls: Add process or administrative controls to limit the risk of vehicle or equipment striking the structure during salt loading operations. This could include adding bollards or other obstructions near the walls to act as guards, or additional training for staff. This also includes preventing loading equipment from contacting roof framing.

Repair Vehicle Strike on North Wall: The timber columns that have buckled should be replaced, or full length 2x added to both sides of the columns. Any broken or buckled sheathing should be replaced and refastened to the timber columns.

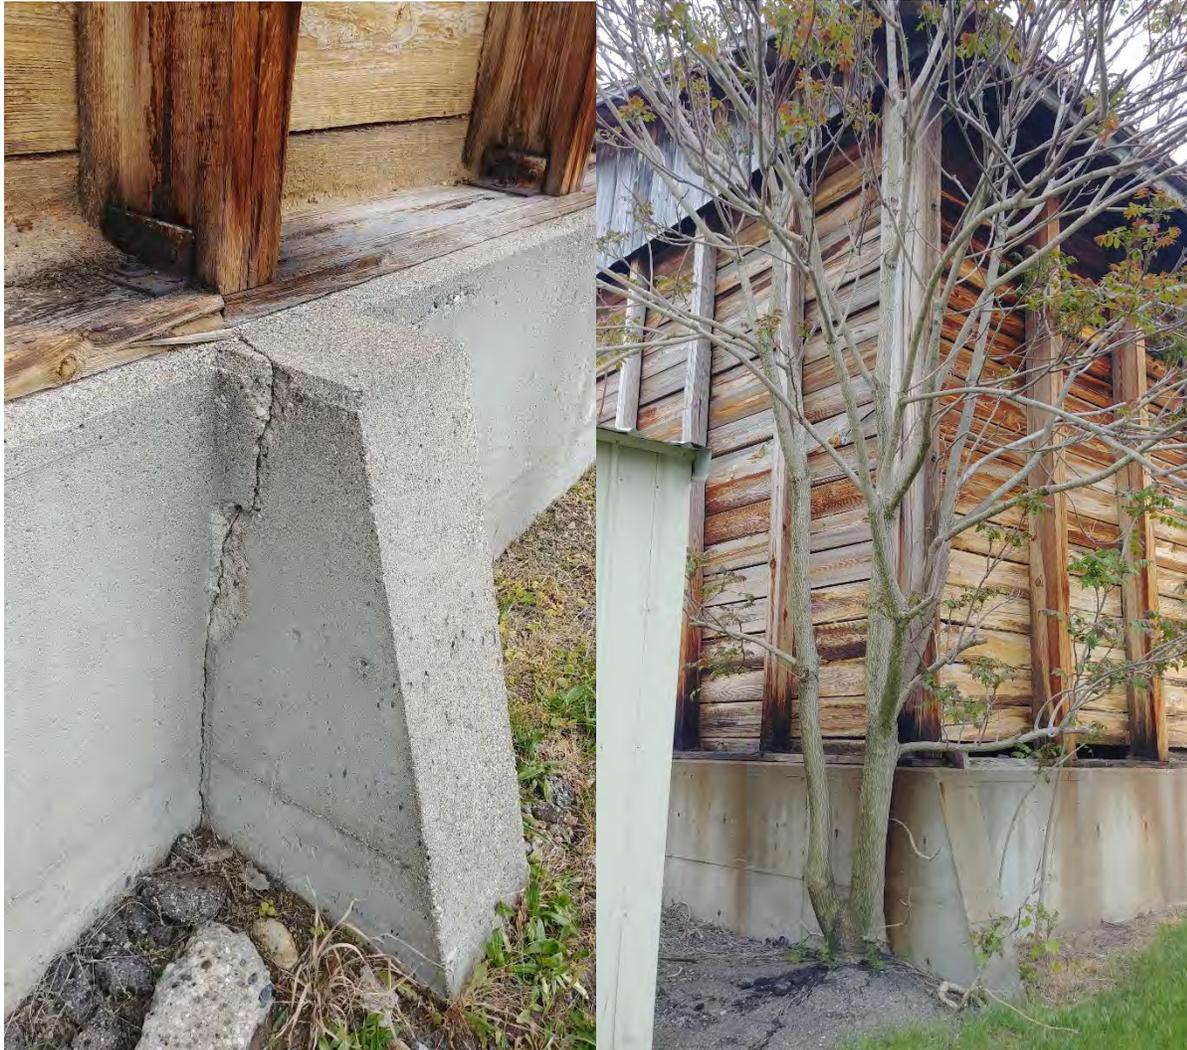
The concrete stem wall has periodic vertical cracks about every 8 feet that penetrate the entire wall thickness. Many of the cracks occur at the interface between the stem wall and the exterior concrete buttresses. Additionally, there is a tree growing next to the foundation at the northwest corner of the structure. Figure 5 shows a typical foundation crack and the tree.

Figure 5: Typical foundation cracking and tree at northwest corner.

The cracking in the foundation I attribute to the lack of control joints and likely inadequate amount of steel reinforcing. The stem wall likely was likely formed in a monolithic pour. The heating and subsequent cooling during the curing process created stresses the concrete could not intrinsically resist. This would also explain why most of the cracks are at the inside corners of the buttresses, which would be an area of stress concentration. Overall, the foundation is functional and performing adequately. However, the cracks allow the stored salt to corrode the interior steel reinforcement.

Seal Foundation Cracks: Use concrete joint sealant to seal the cracks in the foundation. This will help prevent salt from attacking the interior reinforcing steel

Tree Removal: Remove the tree at the northwest corner. The root ball can remain if the tree is preventing from resprouting.
