Vehicle Maintenance Building Structural Evaluation

City of Ypsilanti Public Works Yard
14 West Forest Avenue
Ypsilanti, MI 4897

Date: 31 May 2023

Prepared By: Adam Wagner, P.E.
Wagner Engineering, LLC
Order Number: 2023-071

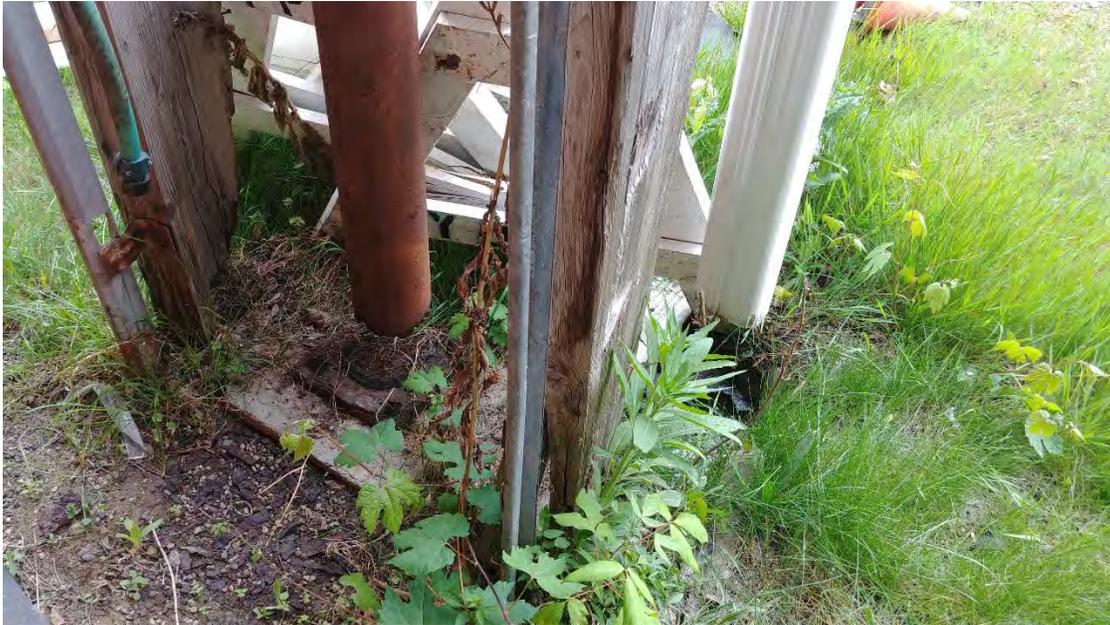
The east shed roof and wall framing was exposed at the time of inspection. The existing roof framing appears to be in good condition. The east wall consists of three bay opening supported by steel columns. One steel column has entirely corroded to the point it is no longer making contact with the footing below, as shown in Figure 1.

Figure 1: Corroded Column Bottom at East Wall of Eastern Shed

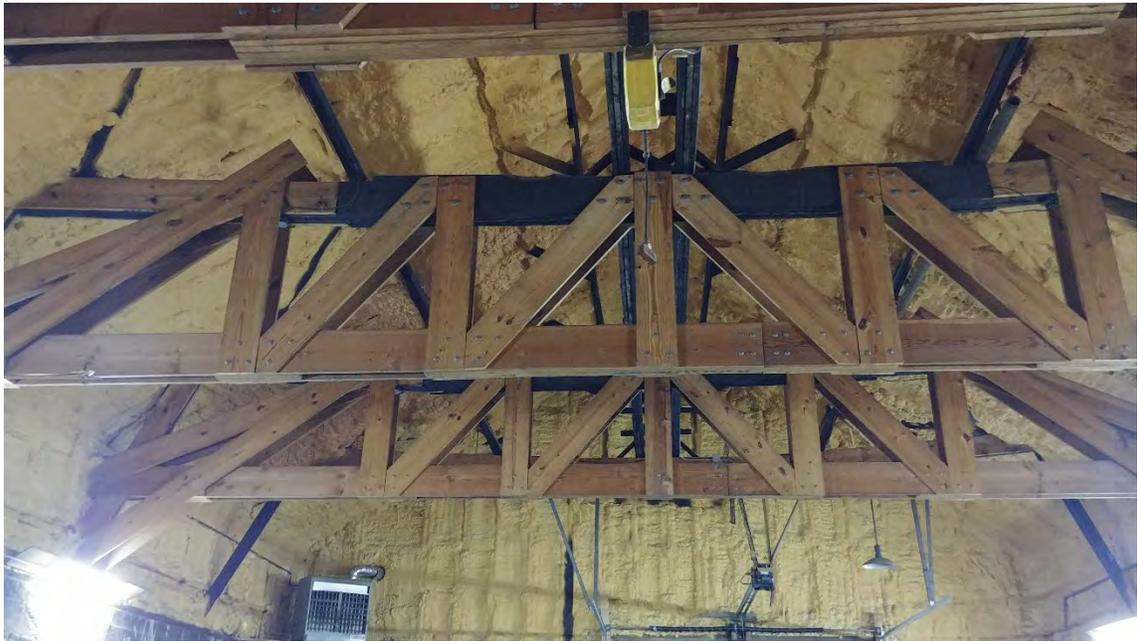
The roof substructure has seen significant modification and alternations over the years. The large timber trusses are likely original. However, many have been rebuilt to replicate the originals. Figure 2 shows a reconstructed roof truss. The trusses are missing along the southern end of the structure and on the north end. In these areas, the purlins are poorly supported, and the roof ridge is sagging as a result. Figure 3 shows the evident sag in the ridge on the southern end of the structure.

Figure 2: Typical Central Vehicle Bay Roof Substructure

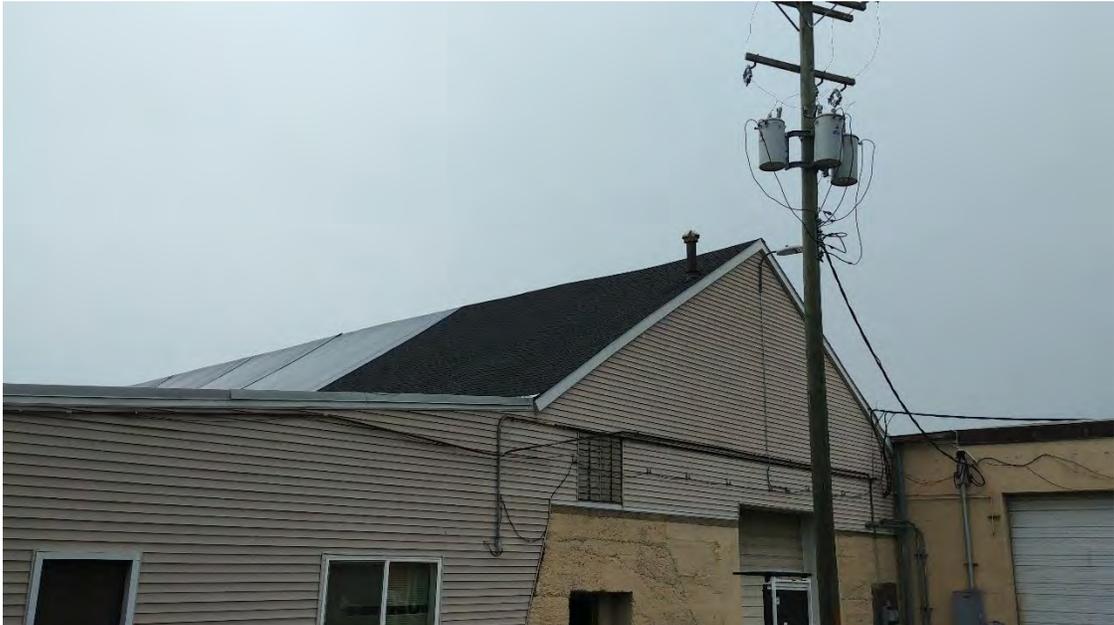
Figure 3: Central Vehicle Bay Ridge Sag on Southern End of Building

This analysis focuses on the Central Vehicle Bay roof. The existing roof structure is undersized in some areas and poorly supported in others. The result is the dead weight of the roof and any additional loading from snow is causing the ridge to sag. The sag is occurring in areas of the roof where the purlins are no longer directly supported by the roof trusses below. The horizontal thrust from the sag is also causing the wood framed wall that is on top of the concrete to lean outward.

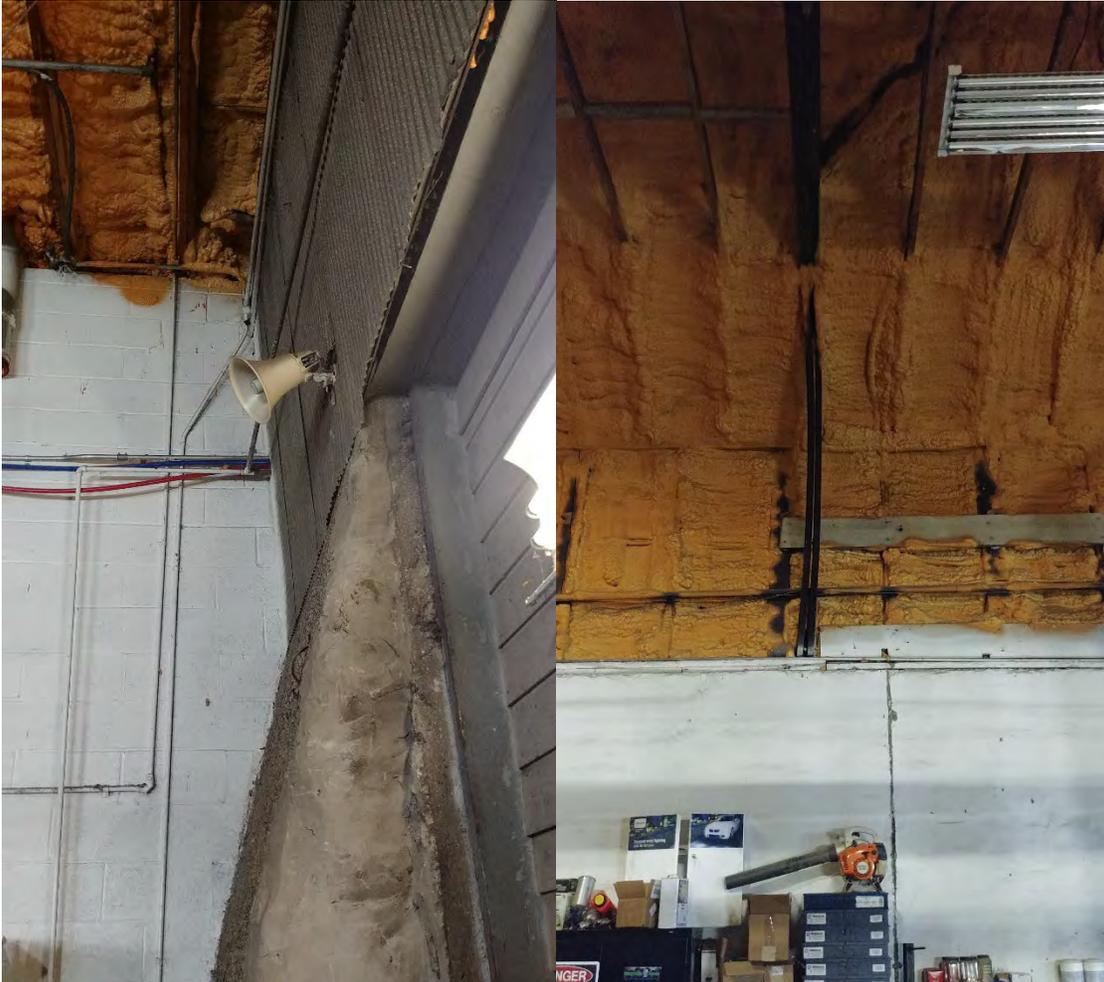
Additionally, in some areas the wood framed knee wall on top of the concrete wall has been forced out of plumb by the horizontal thrust forces from the roof. This is evident in the masonry vehicle bay area as shown in Figure 4. In areas where the wood trusses have been removed, the existing diagonal struts are over stressed and buckling. Figure 5 shows a typical strut that is buckling.

Figure 4: Knee Wall Lean from Roof Thrust

Figure 5: Buckling Strut
