**Fitzpatrick Structural Engineering, P.C.**

Wednesday, March 20, 2013

**Re; Structural Inspection of Smith Furniture Store, Ypsilanti, Michigan**

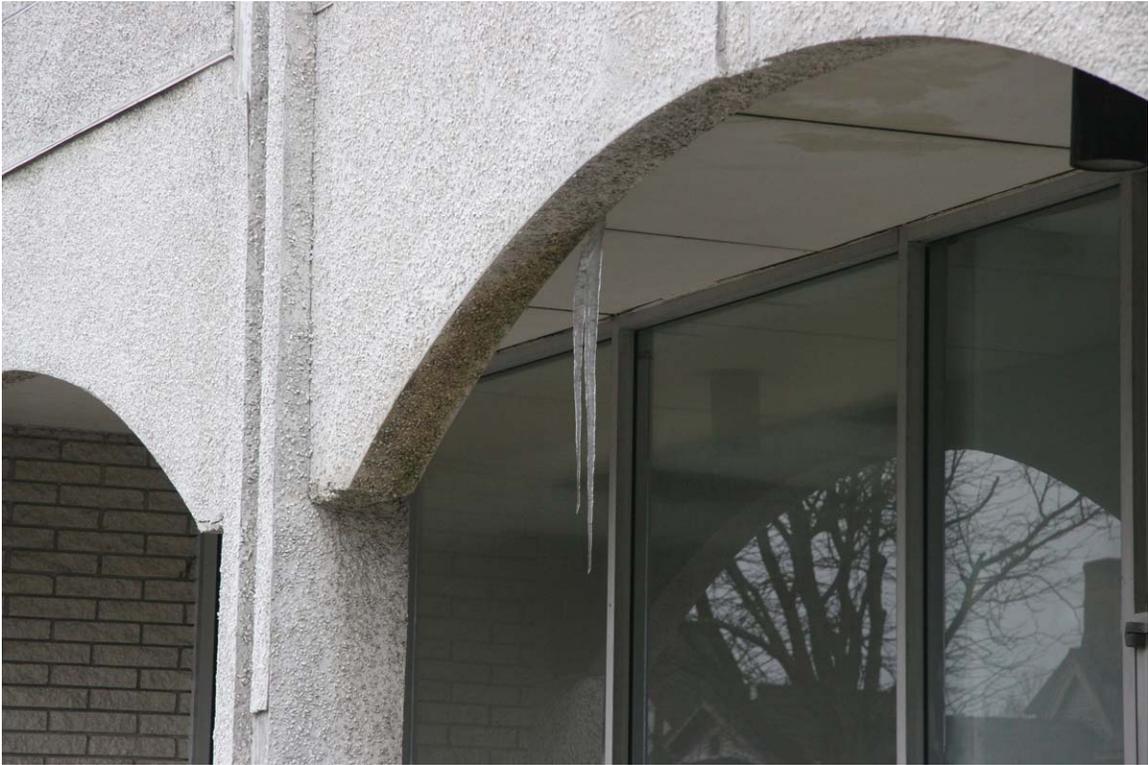
A great deal of water infiltration into the building was observed. There are a multitude of buckets on the first floor and second floor collecting water as it filters down from the roof inside the building. The building is not heated and is not ventilated. Therefore additional moisture problems occur from condensation, especially on cold steel surfaces. The first floor carpet supports organic growth of moss/grass due to the constant wetting. It appeared to be raining at some locations. The magnitude of the water infiltration is extremely harmful to the steel structural elements over time. Photo 01 shows an icicle which indicates water is penetrating failed roof and flashing at the roof above.

Photo 01; East entry façade – icicle indicates failed flashings above. (trf 03.15.13)

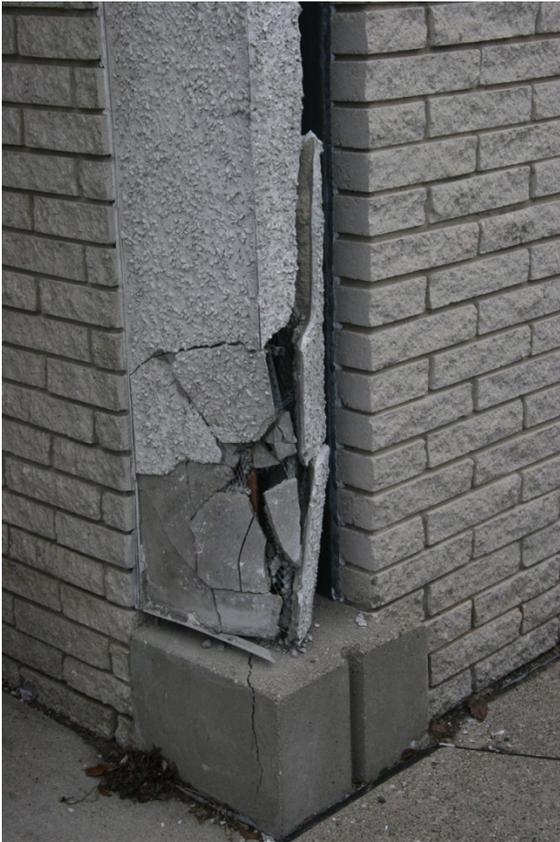
Photo 02 shows the cantilevered end of a joist over a beam at the west edge of the floor area. Some degree of rusting or oxidation can be seen on the joist end and the support beam. This condition appears to be a bit more advanced compared to the roof exposed roof beams and joists. Further inspection of the entire floor is needed, which will require the removal of the ceiling. This also may also permit some visual determination of the anchorage (or lack of anchorage) between the floor and exterior wall.

Photo 02; Column cover damage east façade – note cracked pedestal, steel column undamaged. (trf 03.15.13)

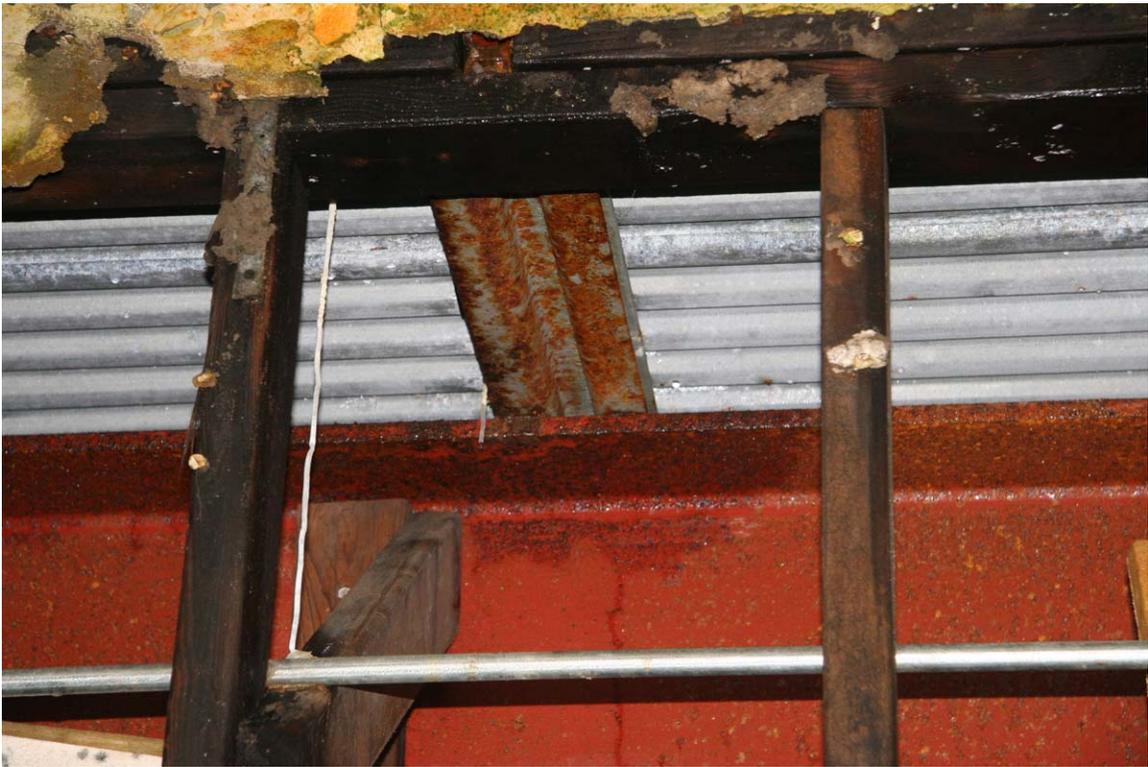
Photo 03; 2<sup>nd</sup> Floor – Joist bearing @ cantilever along west side stairs. (trf 03.15.13)

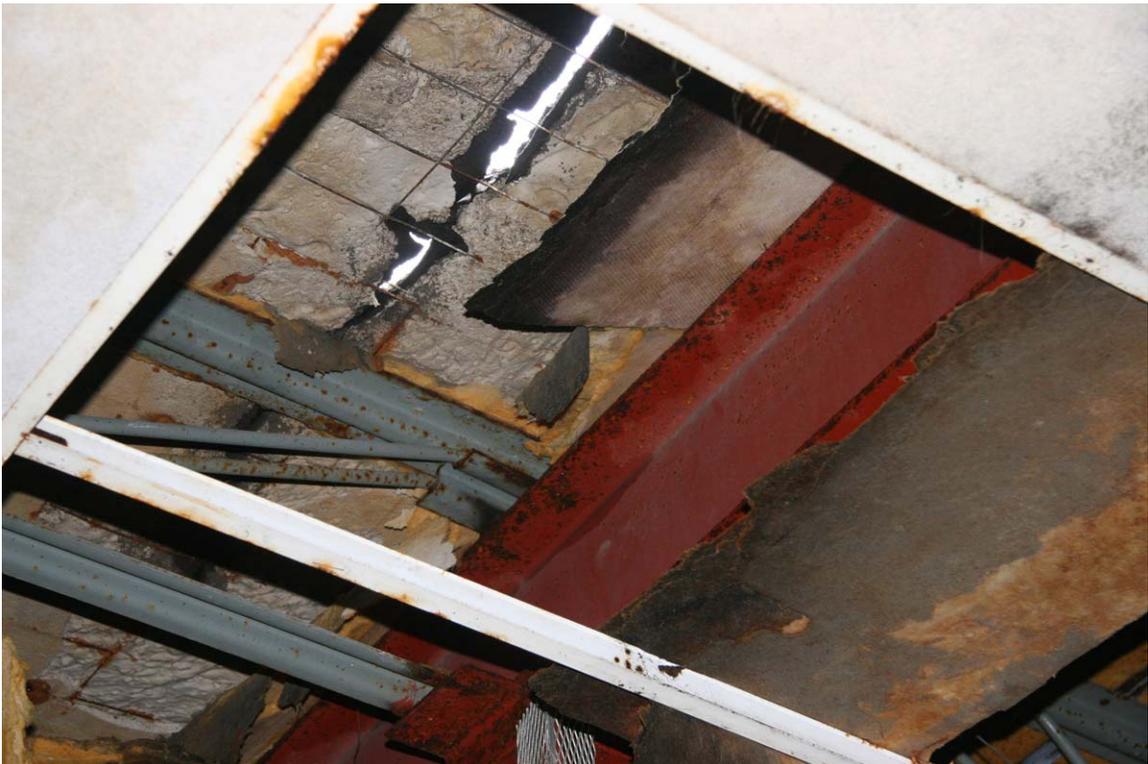
The roof decking system where exposed is in very poor condition as can be seen in Photos 04 through 07. Obviously the roof membrane has failed which has in turn caused daylighting in the gypsum deck (Photo 04) and failure of the soft insulation board. This condition can be considered as typical for the decking given the amount of water infiltration into the lower floor level. It certainly makes the roof deck totally ineffective in providing even marginal diaphragm support for the structure.

Photos 04, 07, and 08 show roof joists bearing on steel wide flange beams. The joists are in fair condition at the locations visually accessed. As can be seen in the photos there is some rusting of the top chord of the joists but this appears to be surface oxidation only. These members are relatively thin and the corrosion can be expected to accelerate with continued exposure to moisture.

Photo 04; Roof – Failed gypsum deck over insulation board at joist bearing on steel beam (trf 03.15.13)

The entire roof deck should be replaced with galvanized steel roof deck. The steel deck should be a wide rib design and a minimum of 20 gage thickness, which is available from several manufacturers. This type of deck meets the Factory Mutual Standards. The design for the roof deck should verify that it can provide diaphragm action. Additionally, the design should provide anchorage to the north and south side walls to provide lateral support for those walls. The roofing shall provide a water tight membrane to protect the interior structure.

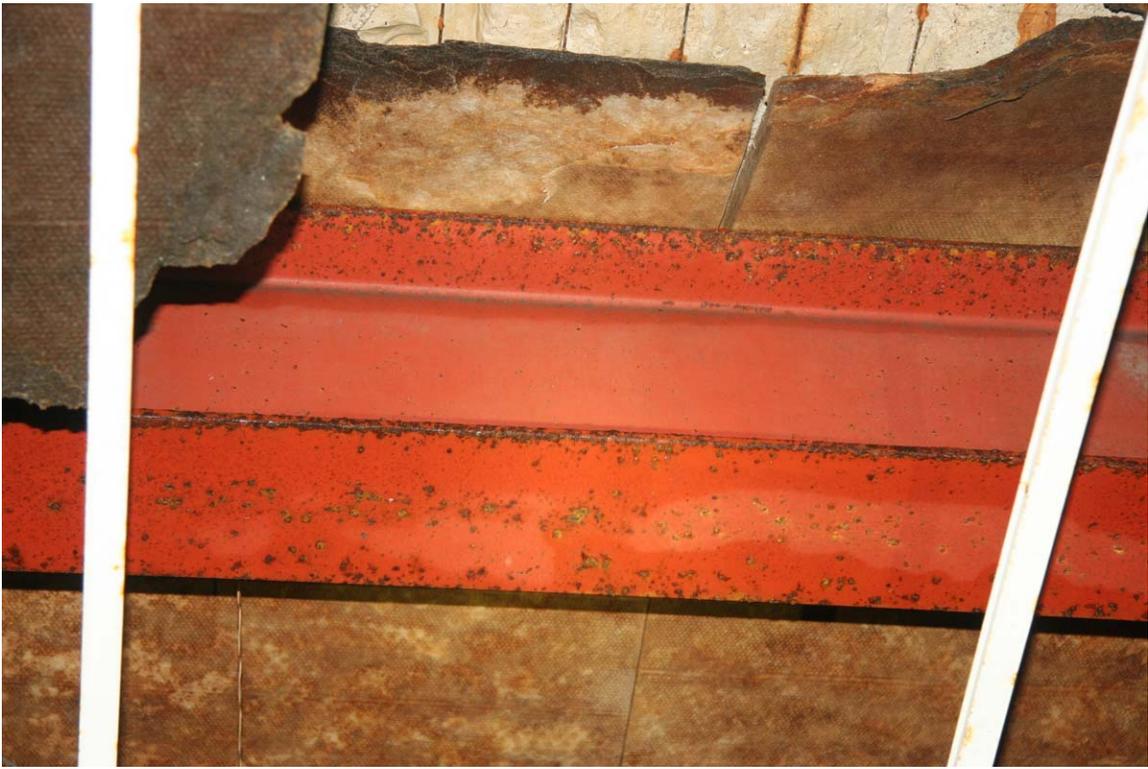
Photo 05; Roof – Close up of gyp deck over insulation board above steel beam, gyp deck appears to have been field placed. (trf 03.15.13)

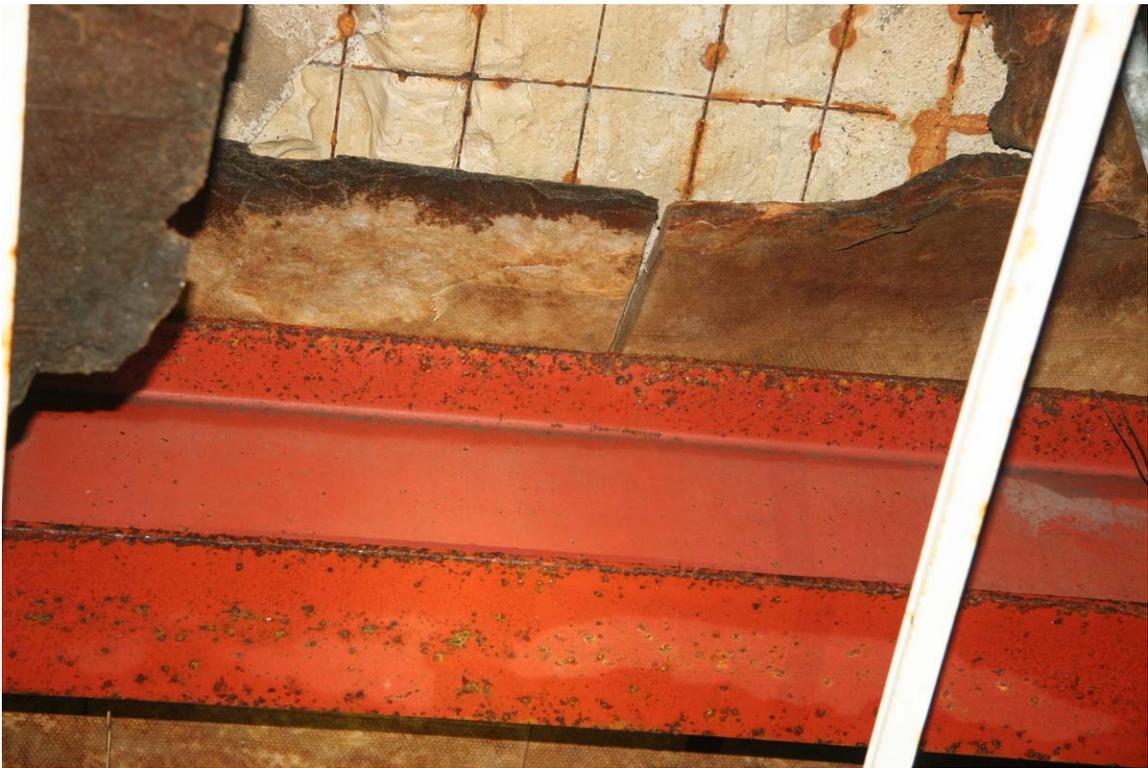
Photo 06; Roof – See photo 05 (trf 03.15.13)

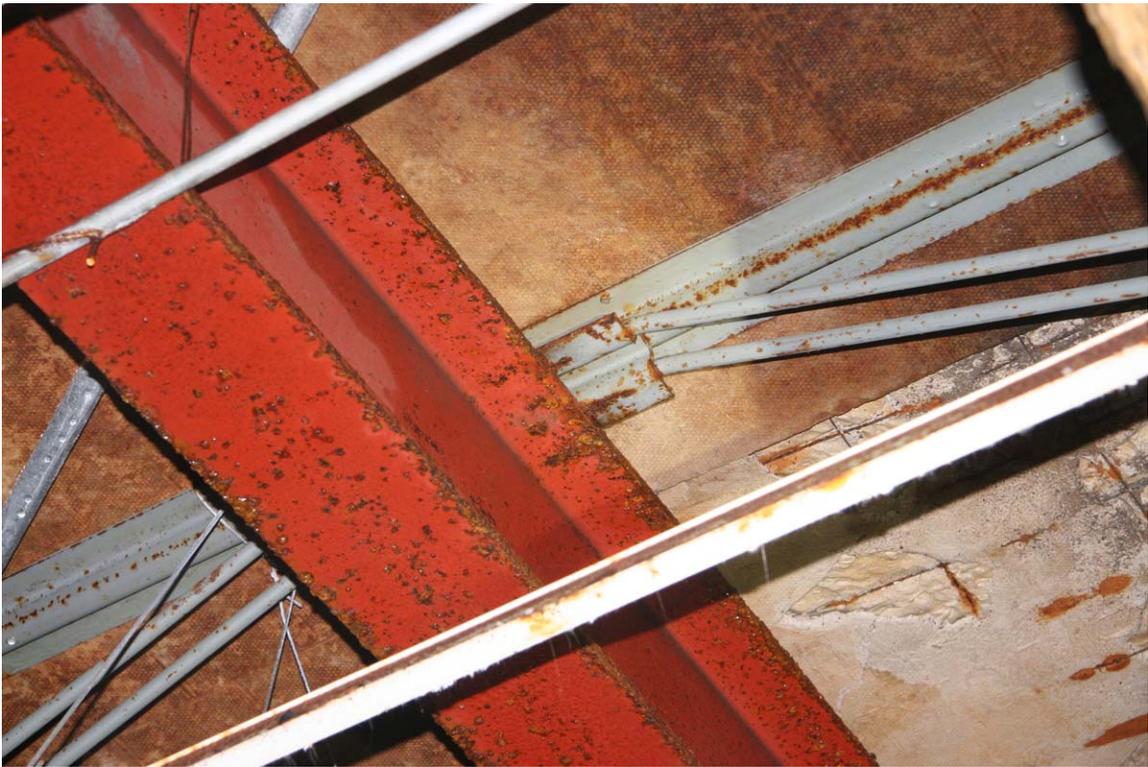
Photo 07; Roof – Joist bearing on beam detail. (trf 03.15.13)

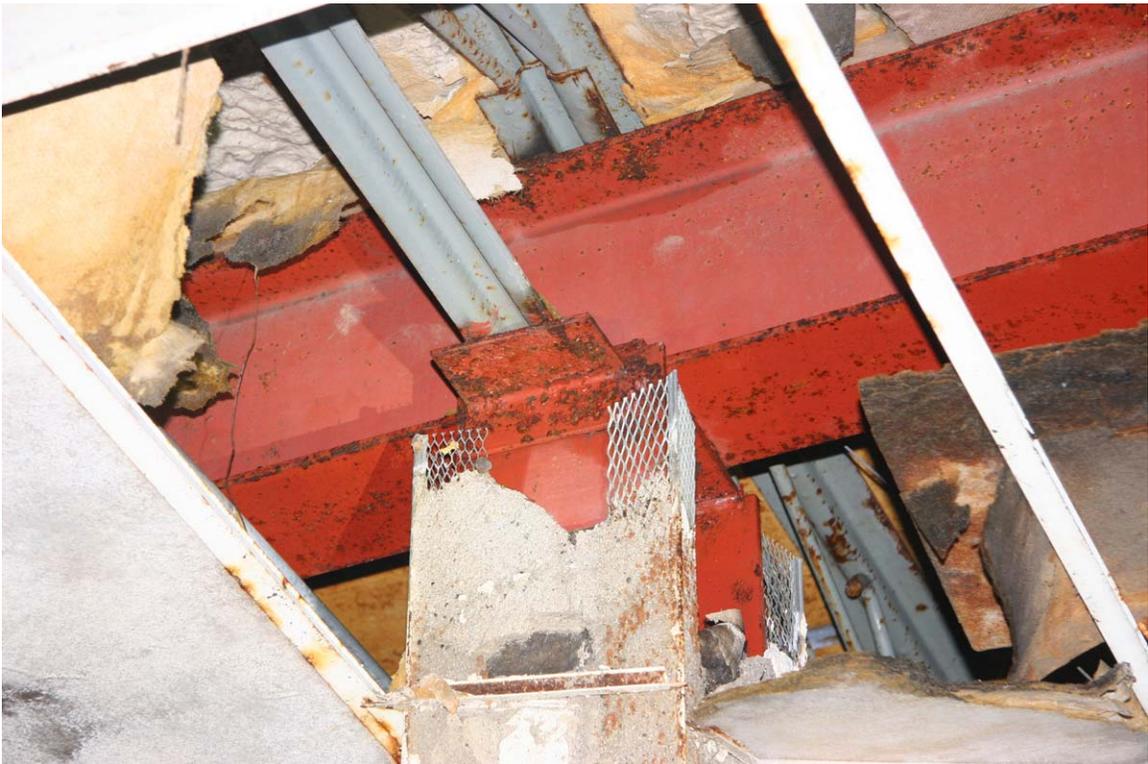
Photo 08; Roof – Joist, beam, column detail. Joist is connected at both bot and top chord providing some lateral resistance in the east-west direction. Beam is continuous over column but connection does not provide full moment and lateral resistance. (trf 03.15.13)

The degree of corrosion of each of these elements should be evaluated for both floor and roof. If the oxidation has not progressed any further than what is indicated by the observations in this report, then no further action is required. If more severe conditions are uncovered, then corrective treatments should be designed and constructed.

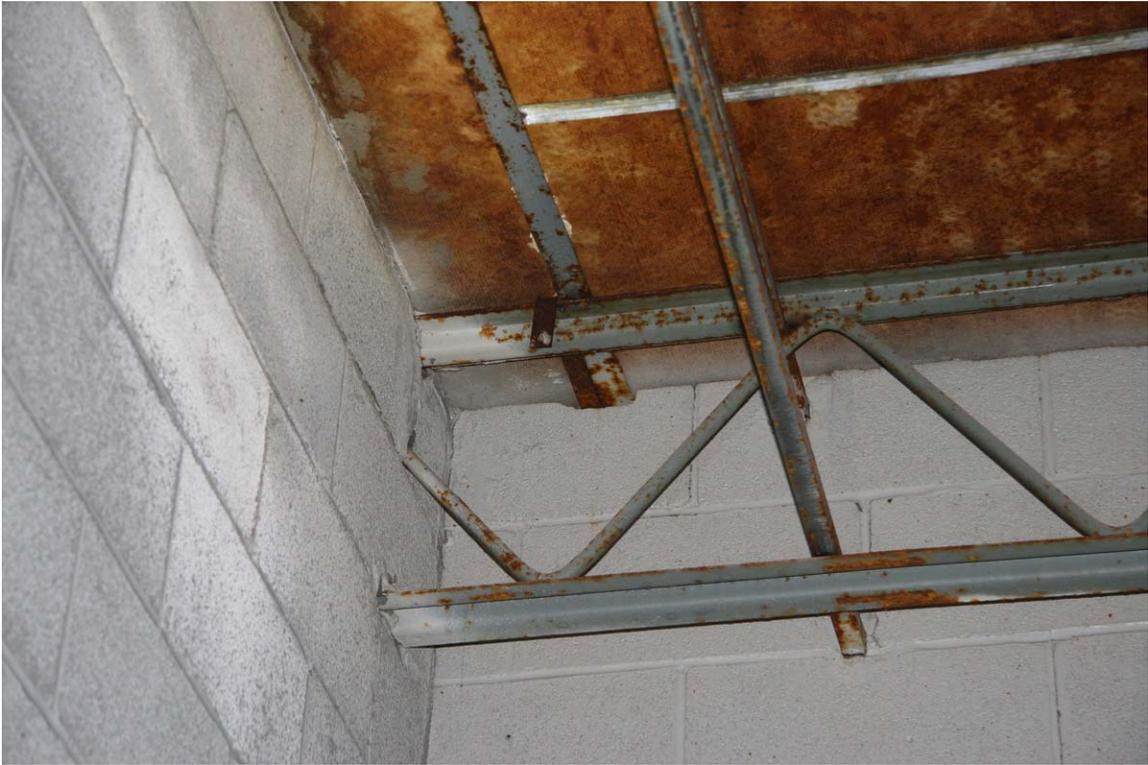
Photo 09; Roof – North wall toward east end, U strap over joist is intended to provide lateral support for the cmu exterior wall except the roof decking is not capable of providing required diaphragm action. (trf 03.15.13)

The anchorage of the floors into the north and south exterior masonry walls is critical to the stability of the overall building. This anchorage should be verified if possible and any indicated corrective measure should be taken.

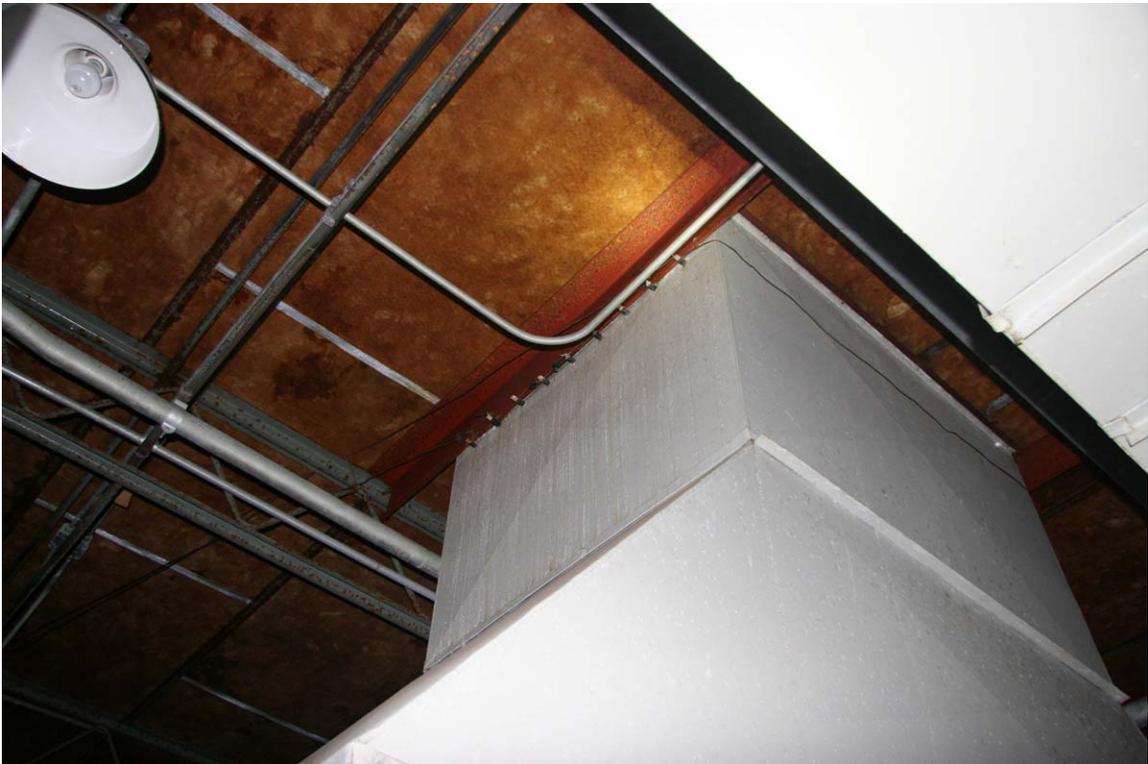
There is a large heating/ventilating/air conditioning (HVAC) unit located on the roof near the east wall. An opening for this unit can be seen in Photo 10. It is assumed that this unit rests on the steel joists in this area. The drawings show special support (beams rather than joists) for a cooling tower near this location. However the joists below the HVAC remain the same size as for the rest of the roof. Usually older HVAC units are relatively heavy compared to modern units and one would expect that the joists would be heavier (or special framing provided similar to the cooling tower) in those locations. This condition should be checked prior to and work on the roof.

Photo 10; Roof – HVAC support at roof opening. Joists don't look beefed up to support the HVAC unit. (trf 03.15.13)

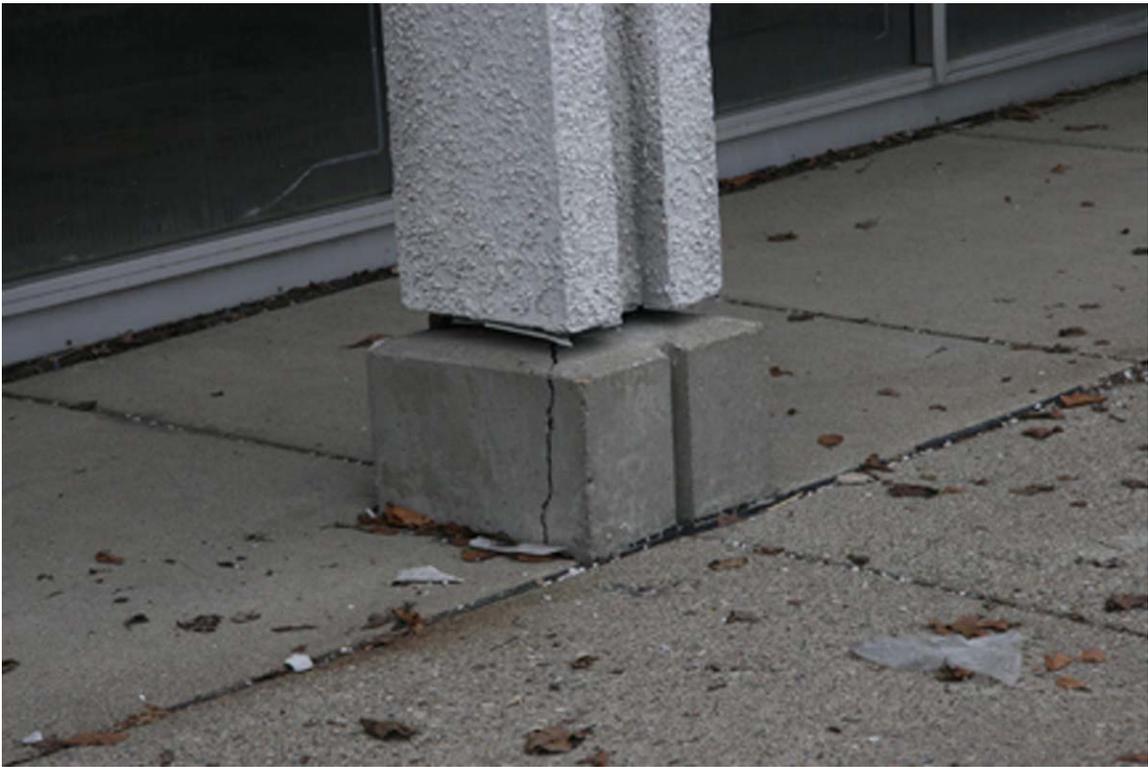
The concrete column base (or plinth) shown in Photo 11 shows apparent severe cracking. This column is located along the east side entry area and is similar to cracking observed along the colonnade on the west side. This condition is most likely due to moisture. The drawings do not show the steel column resting on a concrete plinth and the element may be simply decorative or there may have been some change during construction. In any case the cracking will permit undesirable water penetration into this element allowing damage to any embedded steel and further freeze thaw damage to the plinth.

Photo 11; Column Base – East side is shown, at least two bases at north end of west side similar. (trf 03.15.13)
