MDOT Road Safety Audit: Hamilton and Huron St (US-12-BR) from Interstate 94 to Cross St (M-17)

MDOT

November 14 2018
Ypsilanti, MI

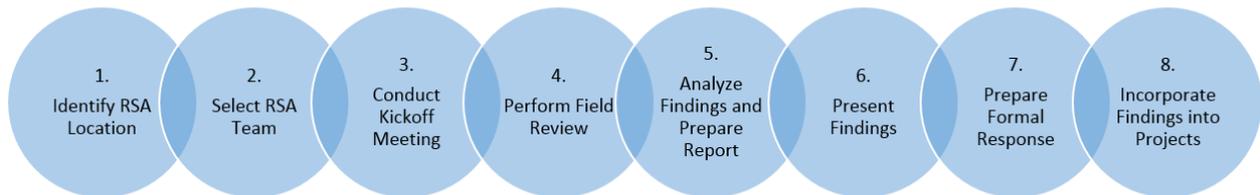
Figure 1-2 The 8-Step RSA Process

This RSA was conducted using framework developed as a part of the Federal Highway Administration's (FHWA) Road Safety Audit Guidelines and associated training course. Safety issues specific to the study corridor were identified during the RSA process and a relative risk rating was provided for each. Treatments and countermeasures aimed to address these safety issues were suggested by the RSA team. Finally, a planning-level economic analysis was performed to provide additional guidance as to the potential impacts of implementing the quantifiable suggestions included in this report. **Figure 2** shows the RSA process applied as a part of this evaluation.

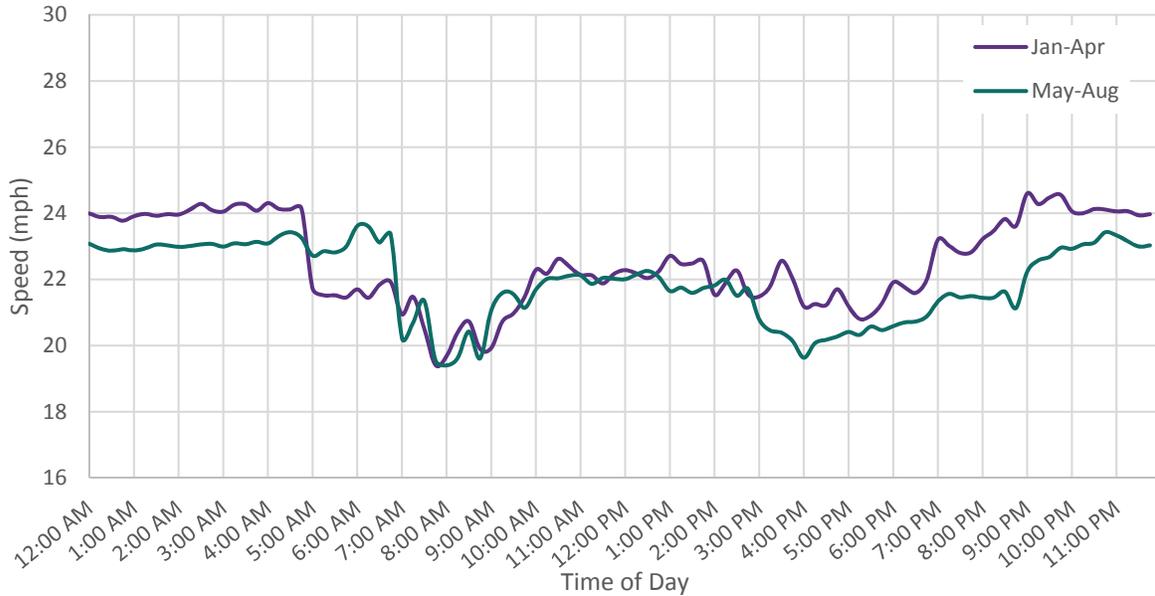
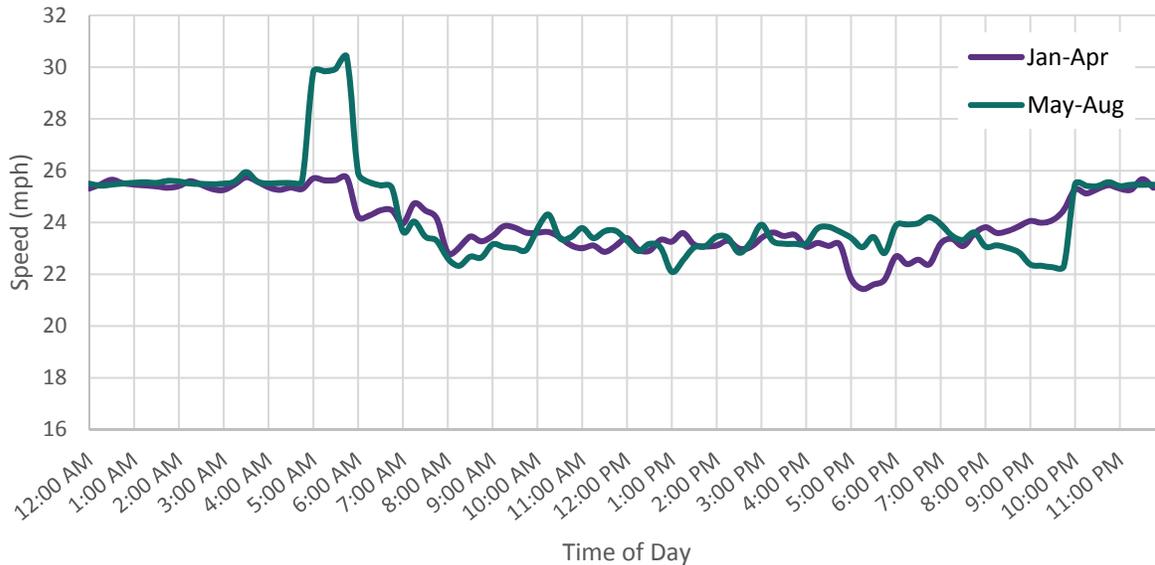
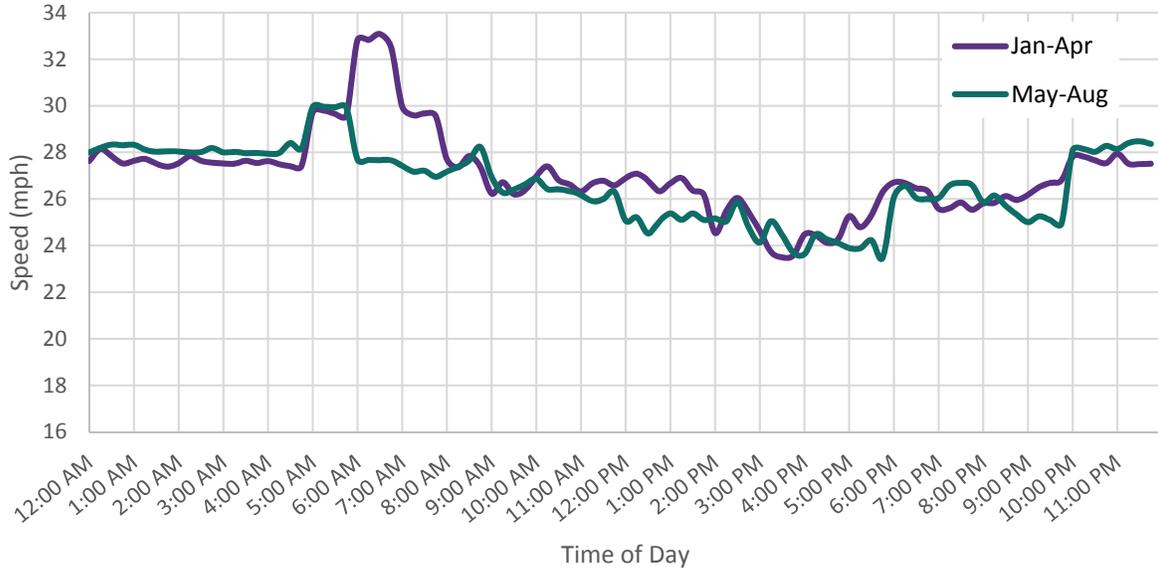
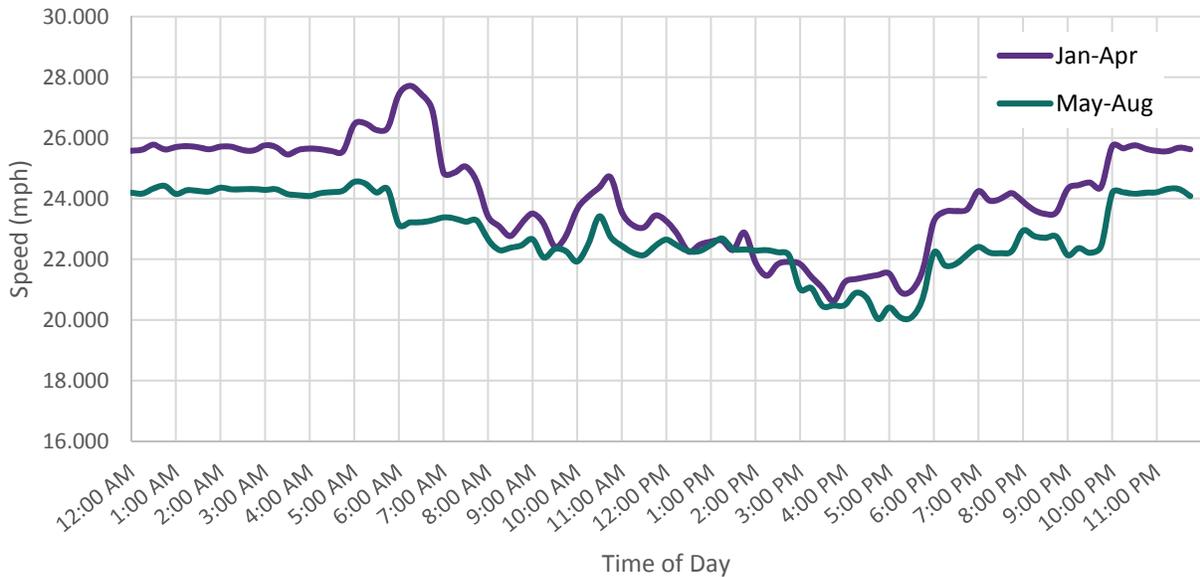
As shown, speeds were greatest during the early AM and late evening for each corridor. Speeds were lowest during the PM peak, where minimum values for each corridor were found. These findings correlate with the congestion observed on the corridor during those times. **Appendix A** provides additional information for each corridor with data provided by each segment as obtained from RITIS.

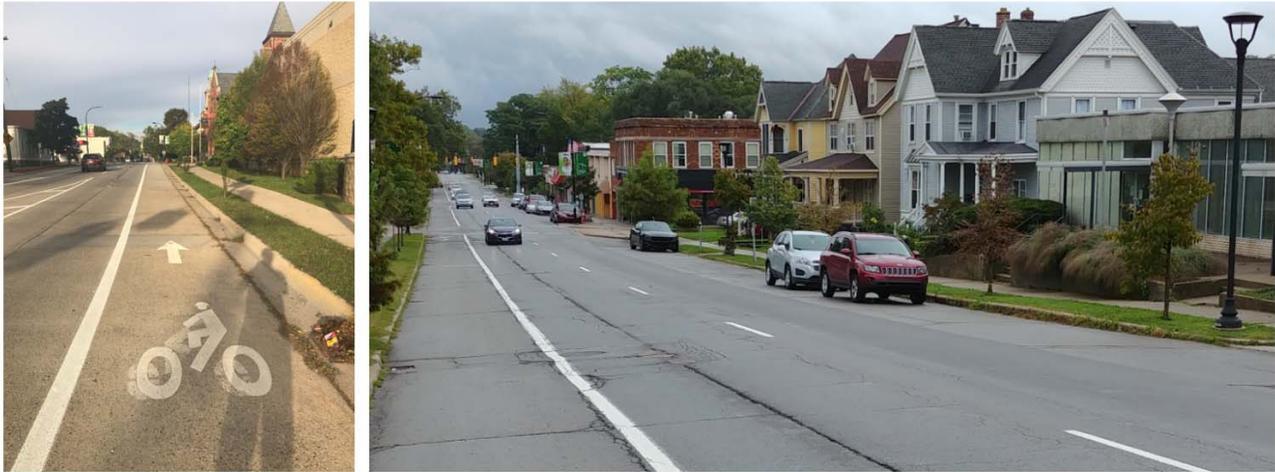
Figure 3-1 View of Bike Lane and Parking along Cross Street

MDOT in partnership with the City of Ypsilanti has already implemented several countermeasures to reduce speeds and improve safety on Cross Street with the inclusion of bike lanes and on-street parking, and on Huron Street from Michigan Avenue to Pearl Street with bulb-outs and on-street parking as shown in **Figures 3-1** and **3-2**. In addition, lighting was observed as operational and illuminating throughout the entire RSA study area.

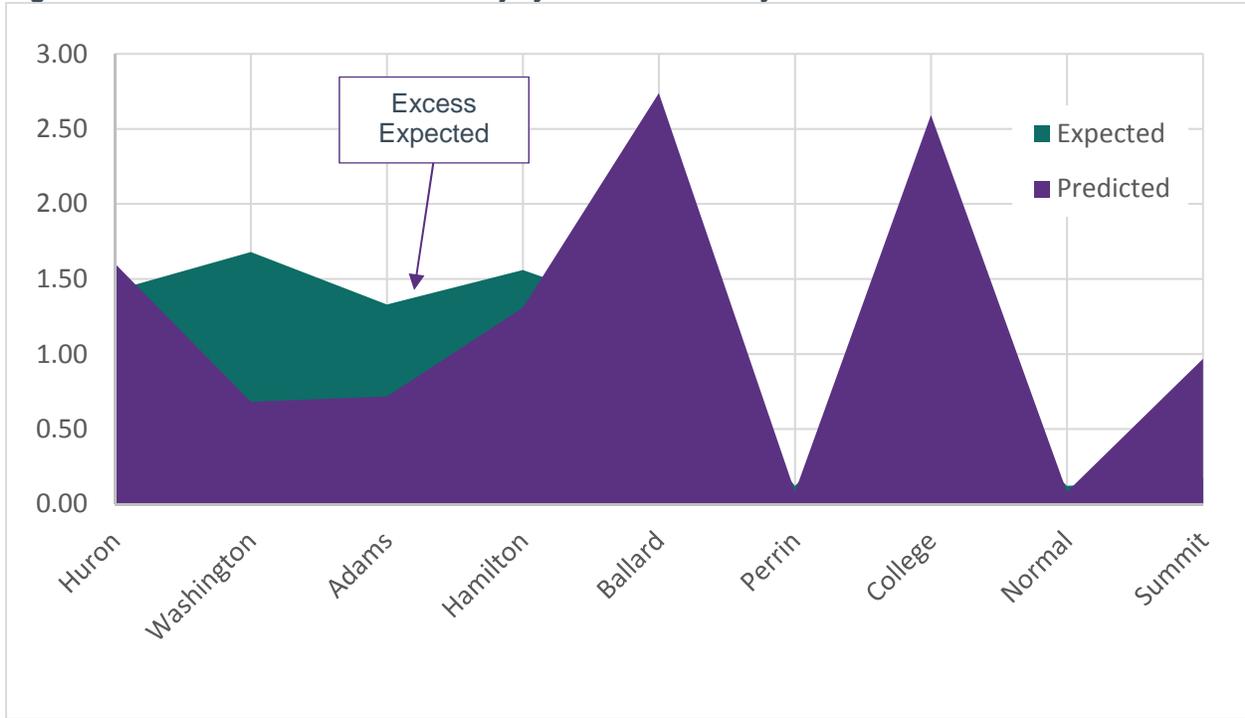
Figure 4-5 Cross Street Fatal and Injury EB-Method Analysis

Overall, each corridor exhibits positive safety performance, where the expected number of crashes is lower than the predicted. This finding is exemplified by the negative excess expected numbers shown in **Table 4-2**, where the facilities are operating better than similar peers. For additional context, charts have been prepared to show the predicted and expected fatal and injury crash values for each intersection by corridor and are shown in **Figures 4-5** through **4-8**. The excess expected shown on these charts represents opportunity for improvement, as those intersections with excess expected are operating with poor safety performance in comparison with other similar intersections. In addition, total crash EB-method analysis charts are provided in the **Appendix C** of this report.

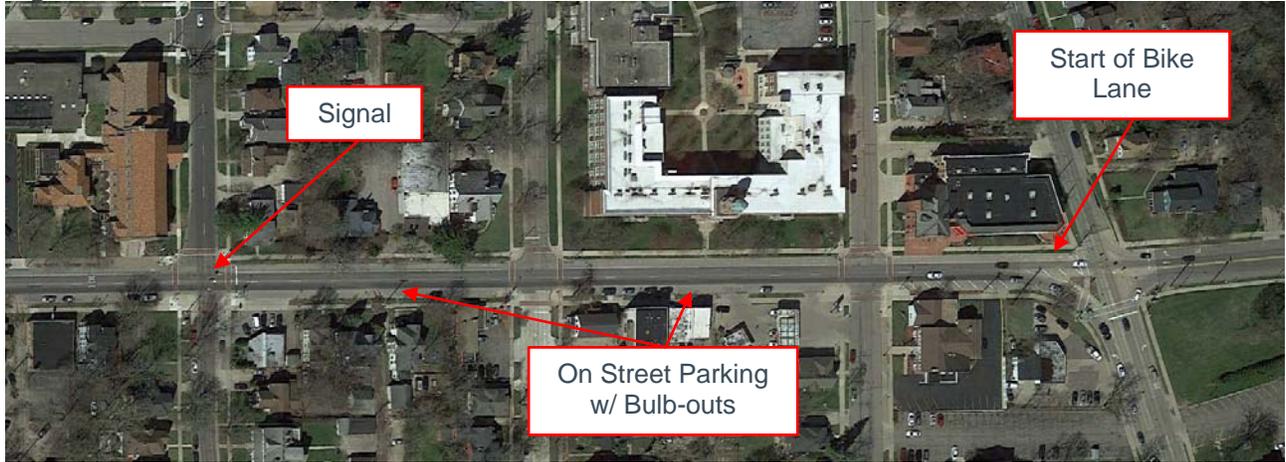
Figure 5-2 Aerial of Cross Street from Huron Street to Hamilton Street

According to speed data obtained from RITIS, the mean free-flow speeds are consistent with the posted speed limit of 25 MPH. However, drivers entering Cross Street from northbound Huron Street using the free-flow lane were observed speeding and crossing over into the right lane in front of through traffic from the east, which would require a speed study to verify. Also, this resulted in a few conflicts (near misses) for sideswipe-same direction crashes observed during field review. Further review of the crash data found that 27 sideswipe-same crashes occurred here over a five-year period.

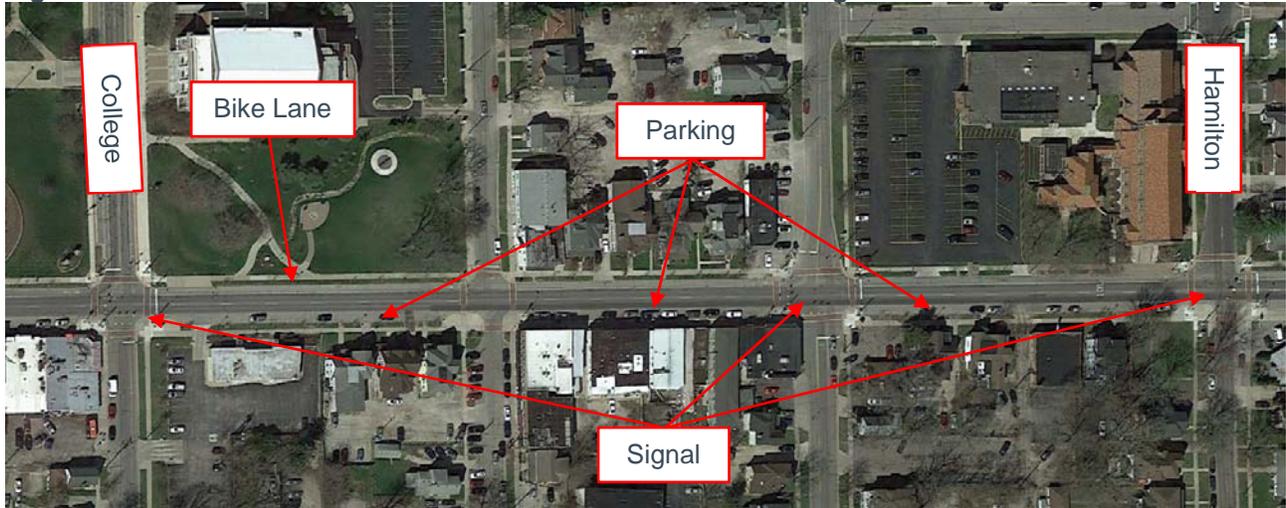
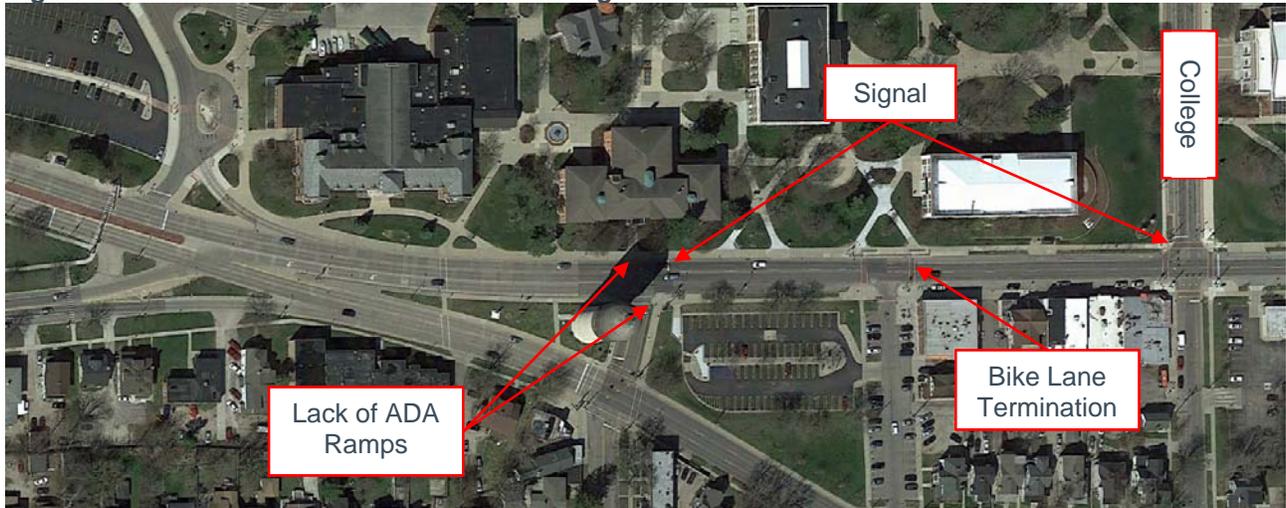
According to speed data obtained from RITIS, the mean free-flow speeds generally agree with the posted speed limit of 25 MPH, except for the period between 5 AM and 7 AM during the months of May through August where average speed exceeds 30 MPH. Based on five-years of data, 8 of the 19 pedestrian and bicycle crashes in the study area have occurred in this section. Moreover, a single pedestrian crash occurred at the unsignalized intersection with Normal Street as follows:

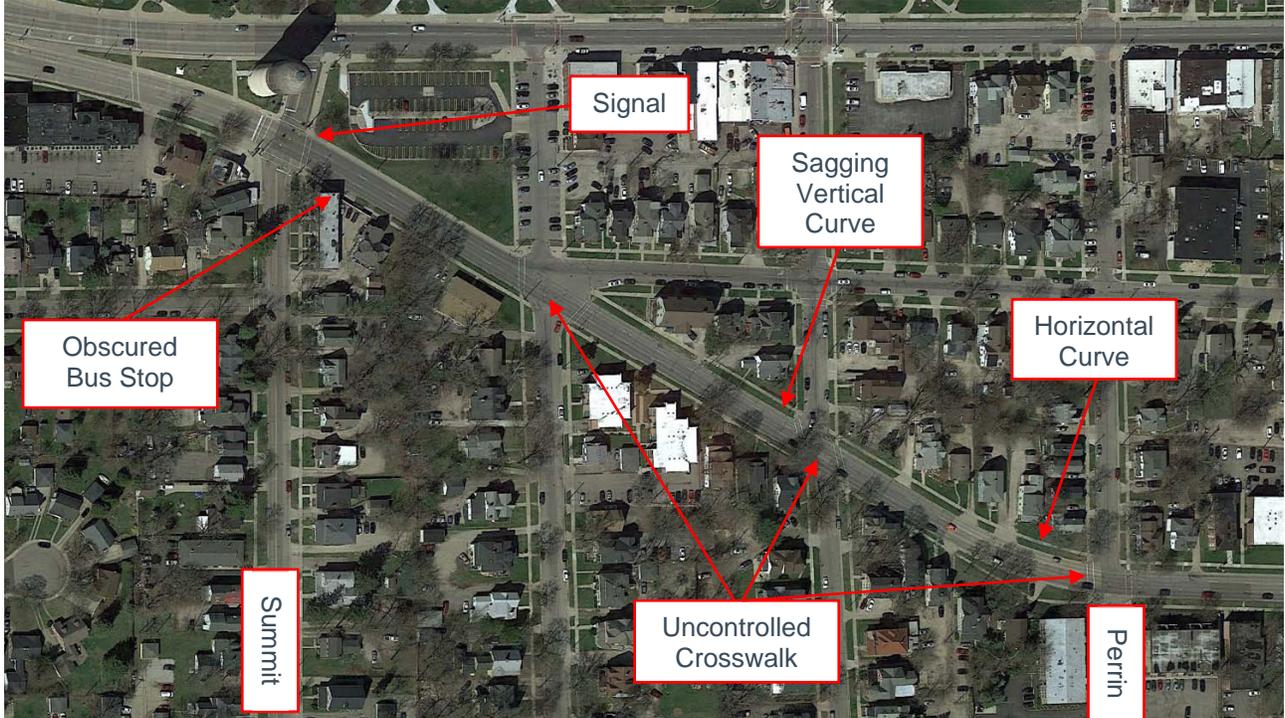
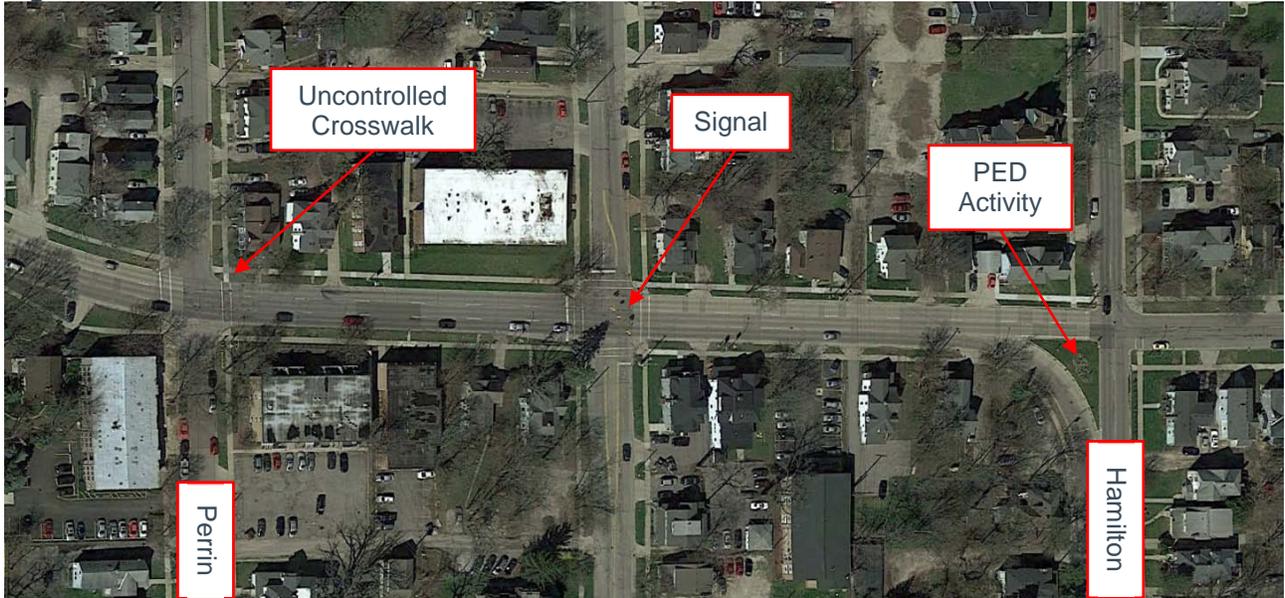
Washtenaw Avenue starting at Cross Street is primarily a three-lane cross-section with a posted speed of 35 MPH. No bicycle lanes are present, and there are a series of uncontrolled pedestrian crosswalks present along the corridor as shown in **Figures 5-7** and **5-8** below. Speeding was observed during field review along the downhill section associated with the sagging vertical curve and should be reviewed by a speed study.

Numerous pedestrians were observed crossing mid-block in front of approaching traffic, particularly in the section between Perrin Street and Hamilton Street. Crossing Washtenaw Avenue at Normal Street was also particularly challenging for the RSA team during field review, where a near-miss was also observed. For reference, two non-motorized crashes occurred in this section during the five-year analysis period:

In addition, there was evidence of pedestrian’s crossing the free-flow right-turn lane that facilitates movement from Washtenaw Avenue to Hamilton Street. Walking paths were observed bisecting the center of the channelizing island there, which was at the apex of the turn. This informal crossing has a higher risk or crash potential as observed in the iRAP analysis in **Section 2.4.1**, as vehicles may not see pedestrians crossing the lane until they’ve already started their turn at speed. The issue of sight distance also effects pedestrians here, as they don’t immediately see vehicles approaching upstream when crossing.

Queuing was also observed during late afternoon and early evening at the Ballard Street traffic signal, where queues extended up to and past Perrin Street with each cycle. Sight distance was an issue here as the queue was not immediately visible when traveling on the downhill section starting at Normal Street. The lack of sight distance coupled with higher vehicle speeds in this section contributes to a greater crash potential. **Table 5-5** summarizes the safety issues observed by the RSA team during this review.

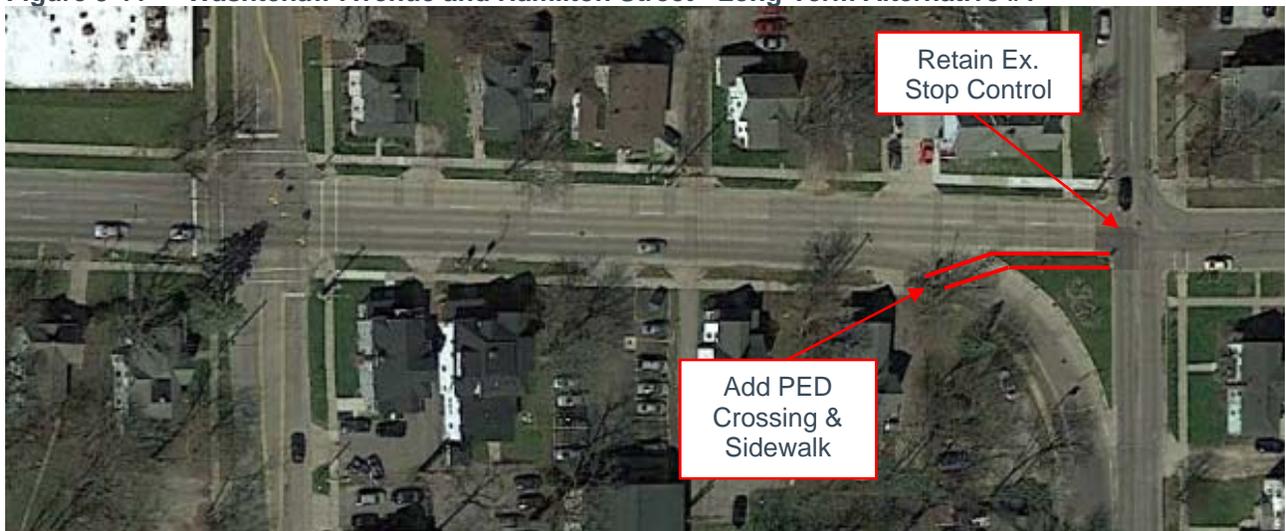
Figure 5-11 Washtenaw Avenue and Hamilton Street - Long-Term Alternative #1

The RSA team developed three potential concepts for the section between Ballard Street and Hamilton Street to address the queuing and pedestrian crossing issues. First, the lowest cost option retains existing geometry but adds a proper pedestrian crossing at the start of the continuous right-turn to Hamilton Street as shown in **Figure 5-11**. This would include the addition of pavement markings, signage, ADA ramps and sidewalk for pedestrians to continue east along Washtenaw Avenue.

#	Suggestion
S-7	Provide enhanced transverse pavement markings and/or in-street pedestrian crosswalk signs
S-8	Implement road diet with buffered bike lane and/or ITS speed warning
S-9	Install W3-4 “Be Prepared to Stop” with flasher interconnected to signal
S-10	Remove signal from Ballard Street; Install signal at Hamilton Street
S-11	Install pedestrian crossing fully visible to approaching vehicles

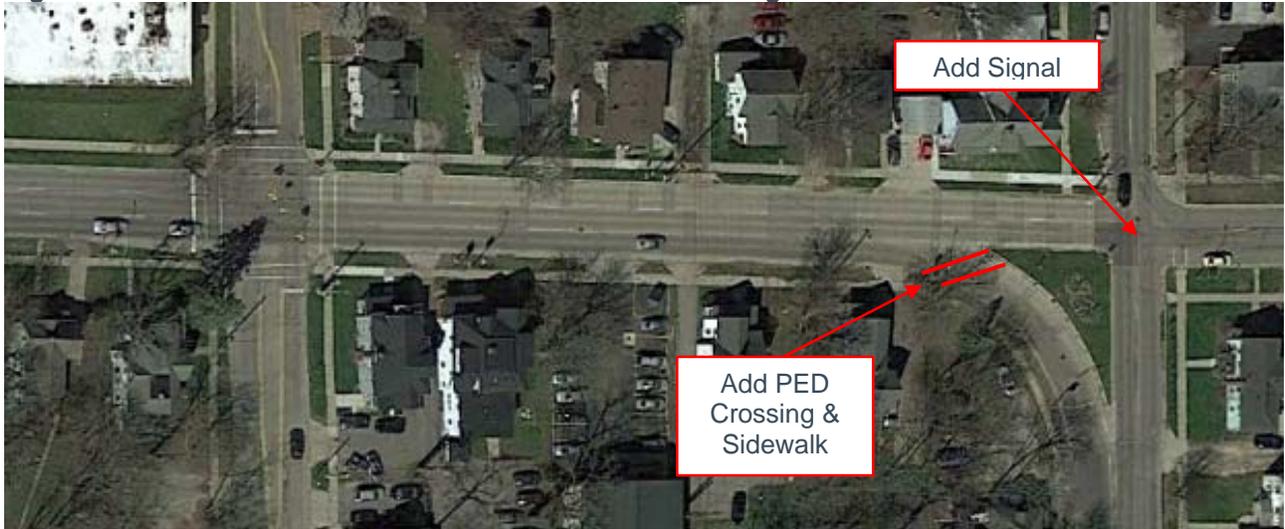
Figure 5-13 Washtenaw Avenue and Hamilton Street - Long-Term Alternative #3

Finally, the third alternative shown in **Figure 5-13**, would include the same signal modifications as presented with the second, but would retain the continuous free-flow right turn to Hamilton Street. This option would still require a pedestrian crossing which is fully visible to approaching drivers and provides for adequate stopping sight distance.

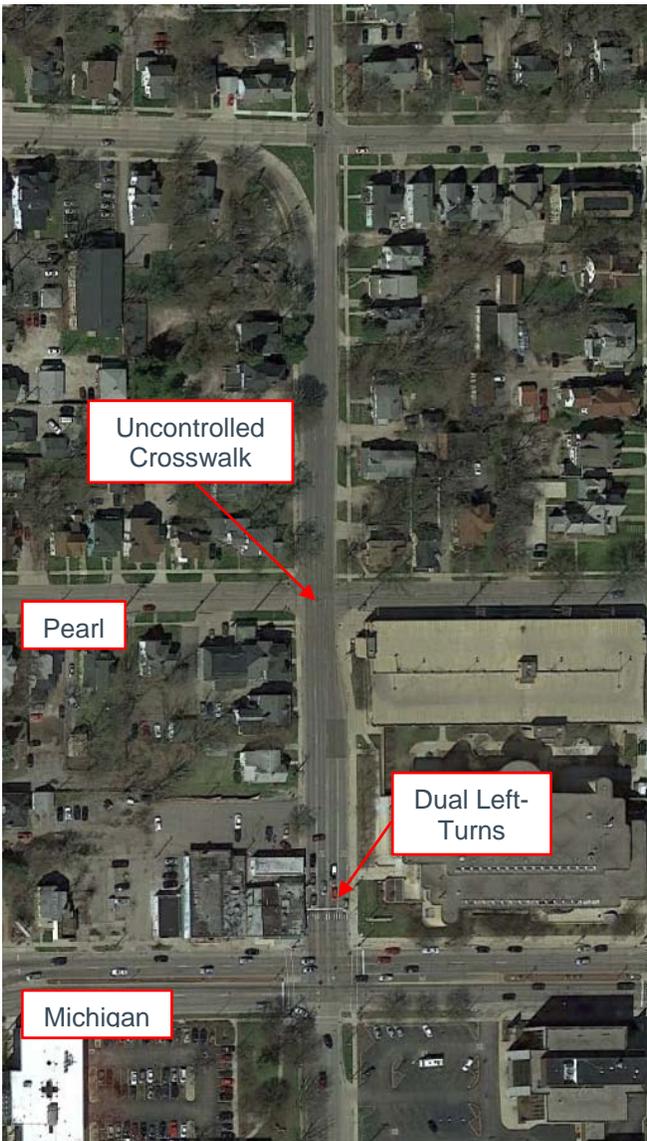
Figure 5-14 Aerial of Hamilton Street from Washtenaw Avenue to Michigan Avenue

Hamilton Street starting at Washtenaw Avenue is primarily a three-lane cross-section one-way in the southbound direction. No bicycle lanes are present, and there is an uncontrolled pedestrian crosswalk at the intersection of Pearl. An AATA transit station is located east of Hamilton Street on Pearl Street, where there is considerable transit bus and pedestrian traffic throughout the day. In addition, a three-story parking structure is in the southeast quadrant of Hamilton Street and Pearl Street, with the Eastern Michigan University School of Business immediately adjacent to the south.

Queuing was observed between 3 and 4 PM at the north leg of Michigan Avenue, which appeared to correspond with class dismissal at the university. Maximal queue lengths were observed to extend back past Pearl Street to the north. Several vehicles appeared to weave from the continuous right-turn lane from Washtenaw Avenue to the left-turn lanes provided at Michigan Avenue. This maneuver was generally conducted at relatively high-speeds and was common during observations.

Vehicles were also observed having difficulty utilizing the dual left-turn lanes at Michigan Avenue, where several positioned in the outside lane were observed to have crossed over to the inside vehicles turning path. This caused the inside vehicle to tighten their turn and drive over the stop bar of left-turning vehicles on the east leg of Michigan Avenue. **Table 5-7** below provides the associated risk with these issues.

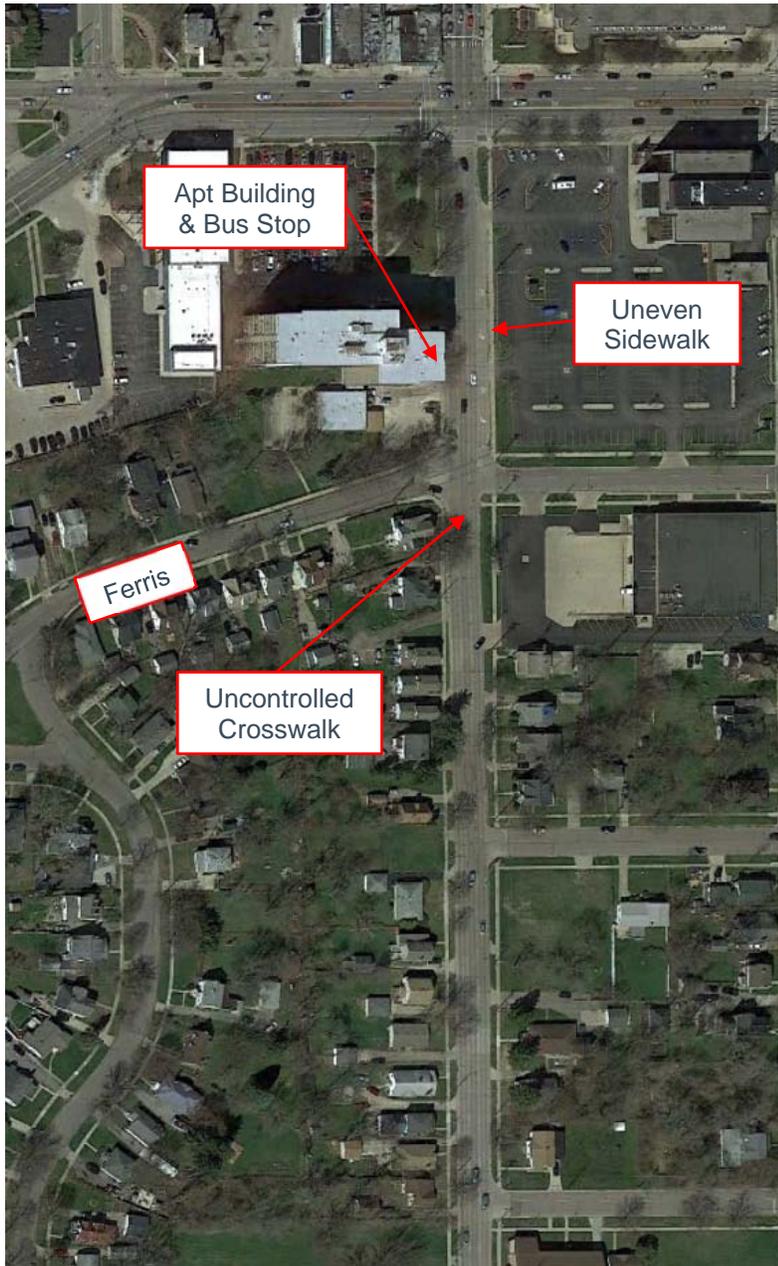
Figure 5-16 Aerial of Hamilton Street from Michigan Street to Catherine Street

Hamilton Street south of Michigan Avenue is primarily a three-lane cross-section with a posted speed limit of 40 MPH. RITIS data indicates a maximum hourly mean speed of 33.2 MPH for the 6 AM hour. That said, the RSA team observed vehicles traveling well over the speed limit throughout the day while studying the corridor. A speed study should be conducted for verification.

Bicycle lanes are not provided, and there are several unmarked crosswalks throughout the corridor. A ten-story apartment building is present just north of Ferris Street with a recently constructed bus shelter in front along Hamilton Street. Sidewalk was present on both sides of Hamilton Street and did not include ADA compliant ramps at the Ferris crossing. The RSA team also found uneven sidewalk on the east side of Hamilton, adjacent to the urgent care building. Also, in that same area, a 265 foot storage bay is provided for left-turning vehicles from Hamilton Street to Ferris Street. It should also be noted that the iRAP analysis indicated a high amount of risk for pedestrians along Hamilton Street.

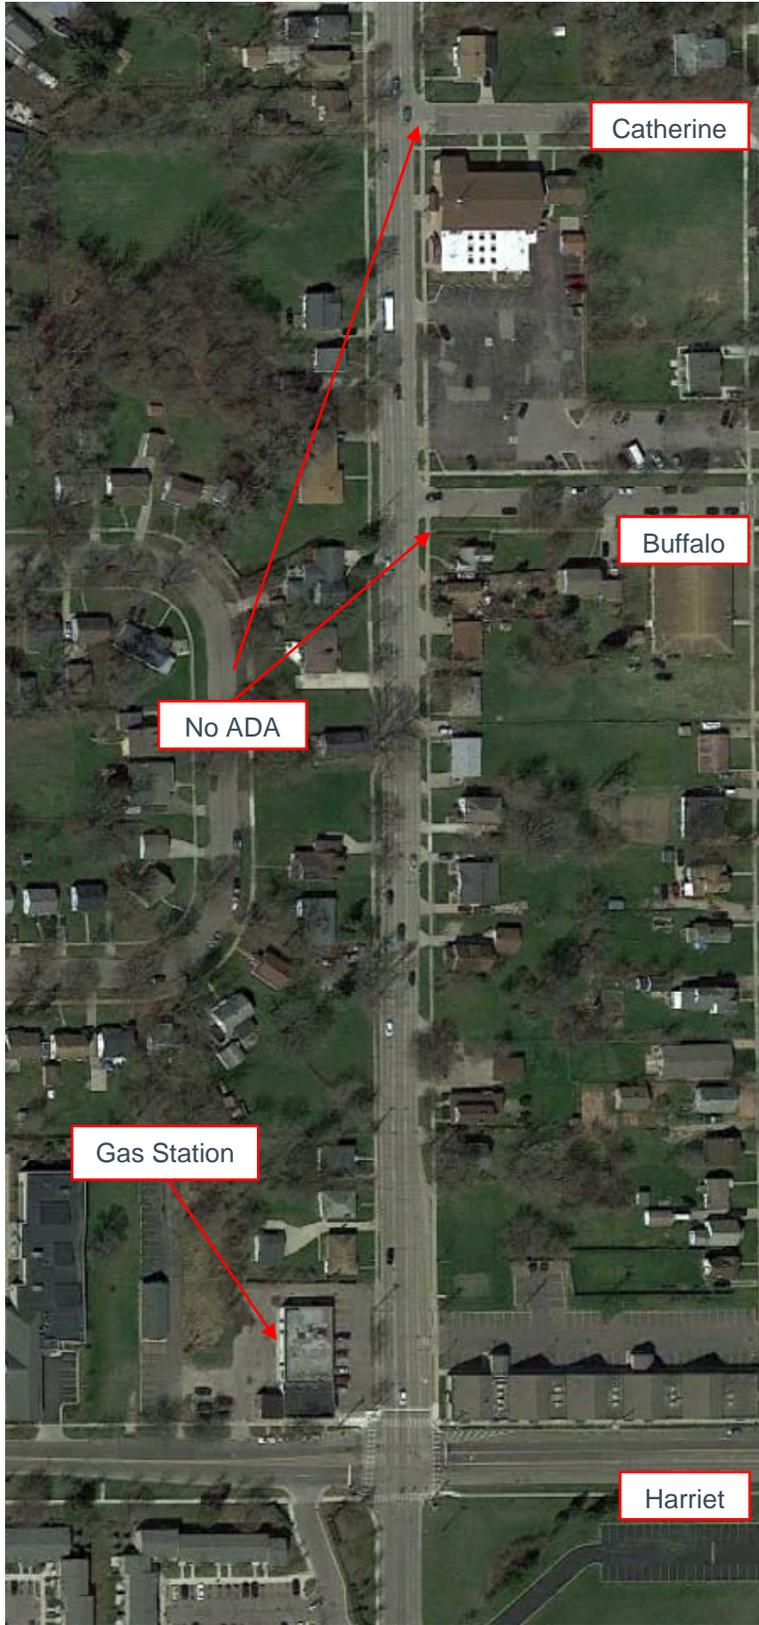
Figure 5-17 Aerial of Hamilton Street from Catherine Street to Harriet Street

Like the previous section, a three-lane cross-section is maintained moving south on Hamilton Street from Catherine Street to Harriet Street with a posted speed of 40 MPH.

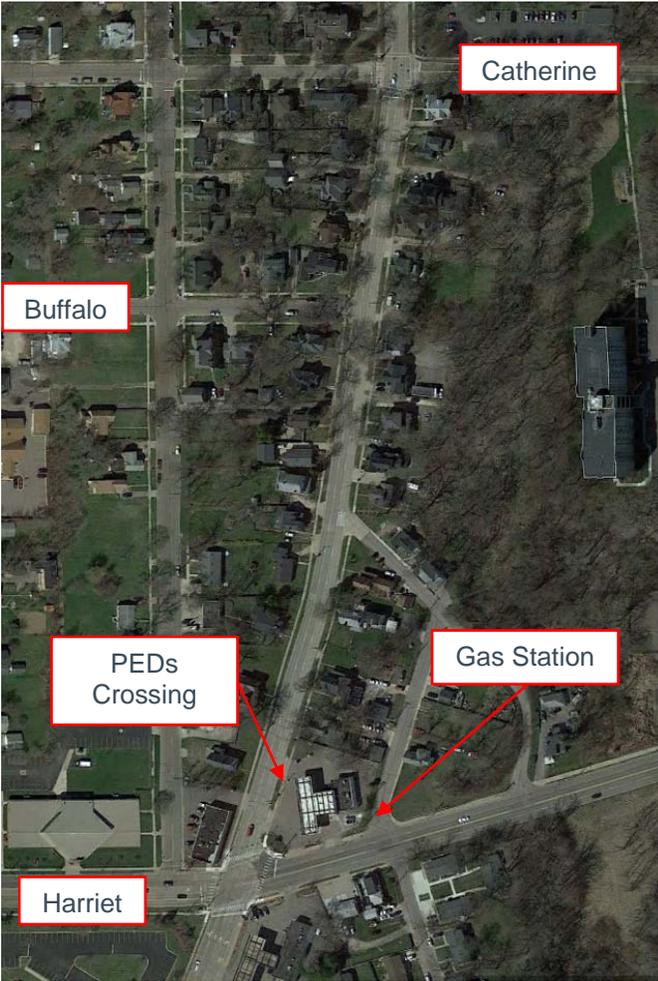
Figure 5-19 Aerial of Huron Street from Harriet Street to Catherine Street

Huron Street from Harriet Street to Catherine Street is primarily a three-lane cross-section one-way northbound with a posted speed limit of 40 MPH. No bike lane is provided, and sidewalk is present on both sides of Huron Street throughout the length of this segment.

Like Hamilton Street, this segment of Huron Street is primarily residential with numerous driveways throughout. A gas station exists in the northeast quadrant of the intersection with Harriet Street, where several driveways facilitate access. During the RSA field review, pedestrians were observed crossing from the most northern gas station driveway to an alley behind party store bisecting Huron Street and Washington Street.

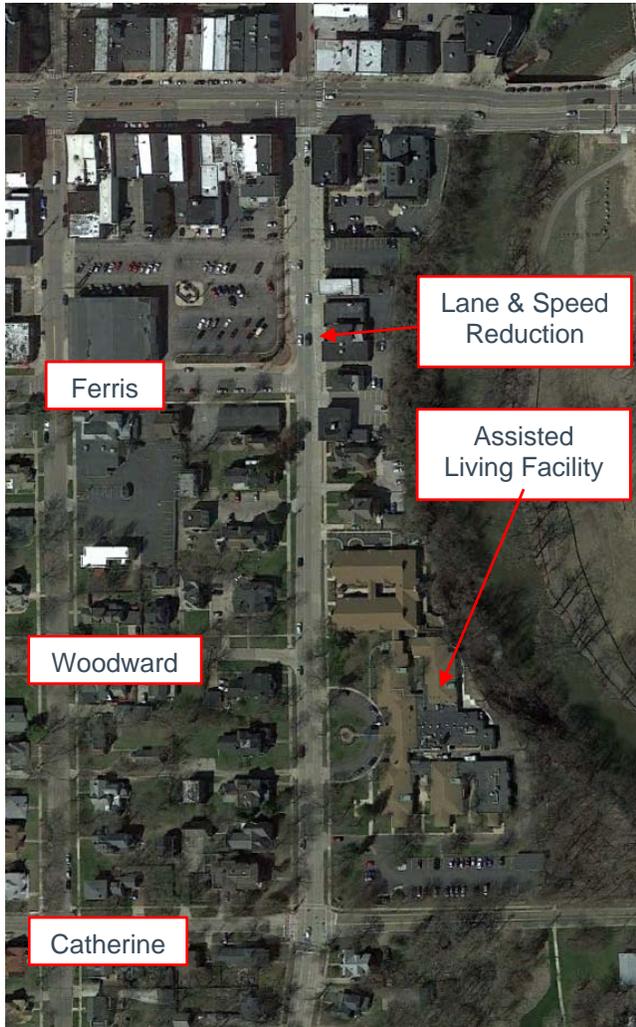
Figure 5-20 Aerial of Huron Street from Catherine Street to Michigan Avenue

Huron Street from Catherine Street to Michigan Avenue is primarily a one-way northbound roadway with a three-lane cross-section. Speed limits range from 30 to 40 MPH, where 40 MPH exists from Catherine Street to Ferris Street, and 30 MPH is enforced from Ferris Street to Michigan Avenue. At Ferris Street, Huron Street is reduced to a two-lane cross-section that continues north to Michigan Avenue, where a 260 foot left-turn bay is provided along with a through and shared through-right. The lane reduction is facilitated by pavement markings and signage only. No bike lane is provided, and sidewalk is present on both sides of Huron Street throughout the length of this segment.

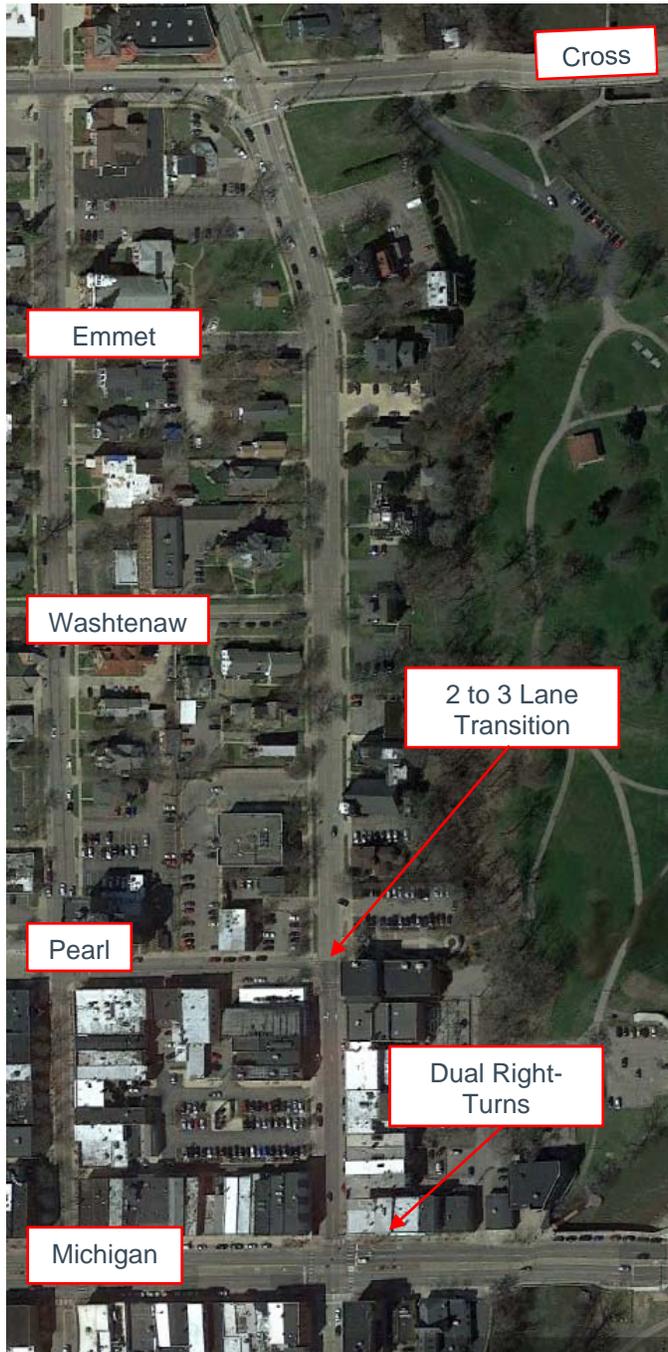
Figure 5-23 Aerial of Huron Street from Michigan Avenue to Cross Street

Huron Street from Michigan Avenue to Cross Street begins as a one-way northbound roadway, that starts with a two-lane cross-section that expands to three lanes after Pearl Street. Bulb-outs with on-street parking are present in the section from Michigan Avenue to Pearl Street, with a marked pedestrian crosswalk provided at the intersection with Pearl Street. Speed limits range from 30 to 35 MPH, where 30 MPH exists concurrent with the on-street parking between Michigan Avenue and Pearl Street, and increases to 35 MPH with the cross-section change after the intersection with Pearl Street.

The RSA team felt the transition area north of Pearl Street had the potential for causing safety conflicts when driving the corridor, as the center lane of the three lane section can be accessed by vehicles in either of the two lanes in the two lane section. Also, Pearl Street was under construction and blocked during the review period and unable to be assessed. Since this intersection was an area of concern for local stakeholders, it should be studied separately under normal operating conditions for pedestrian safety due to the proximity to the bus station.

Finally, when reviewing the intersection with Cross Street, the pedestrian signal was found to confuse drivers leading to reduced compliance with the left-turn signal. Vehicles were observed driving through a solid red after waiting for a substantial period of time without any cross traffic. Some vehicles treated the signal as a yield with minimal stop time. When presented with a green signal, vehicles appeared to use the left-turn lane from Huron Street to Cross Street at relative high speeds, where one RSA team member was nearly sideswiped on Cross Street after a vehicle came through the left-turn lane.

For the lane shift after Pearl Street, the RSA team recommends continuing the road diet with parking along the corridor as a long-term solution. This would maintain the two-lane alignment and prevent any conflicting lane

Finally, for the signal issues at Cross Street, a signal study should be conducted to review phasing requirements and to assess the current operations at the intersection in more detail. This study should also seek to evaluate pedestrian usage and determine if the current pushbutton operation is appropriate. To reduce sideswipe-same crashes related to vehicles exiting the left-turn onto Cross Street, extending solid pavement markings or introducing a raised median to prevent the lane-change maneuver are recommended.

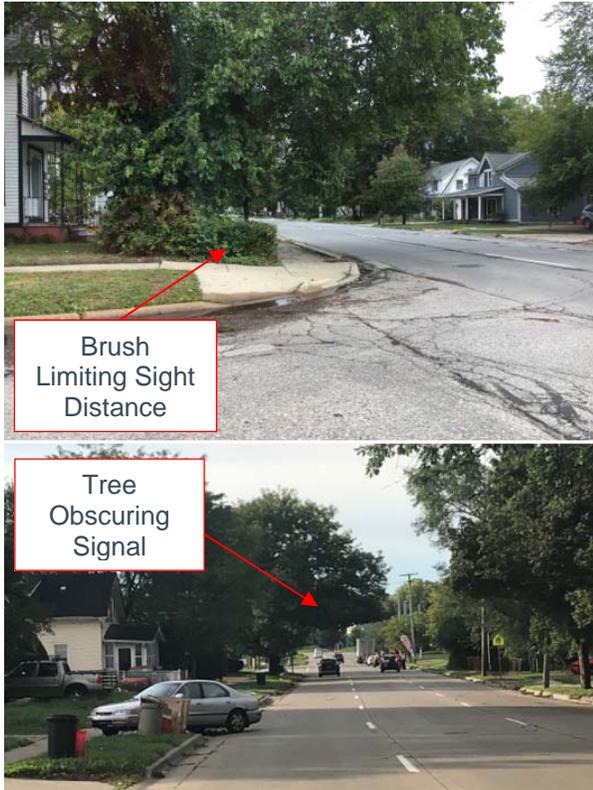
Figure 5-25 Sight Distance and Signal Obstructions

General issues observed along the corridor included several instances of vegetation limited sight distance of vehicles entering the corridor. In addition, there was also one case of a tree obscuring the traffic signal at Hamilton Street and Harriet Street. Examples of these findings are shown in **Figure 5-25**.

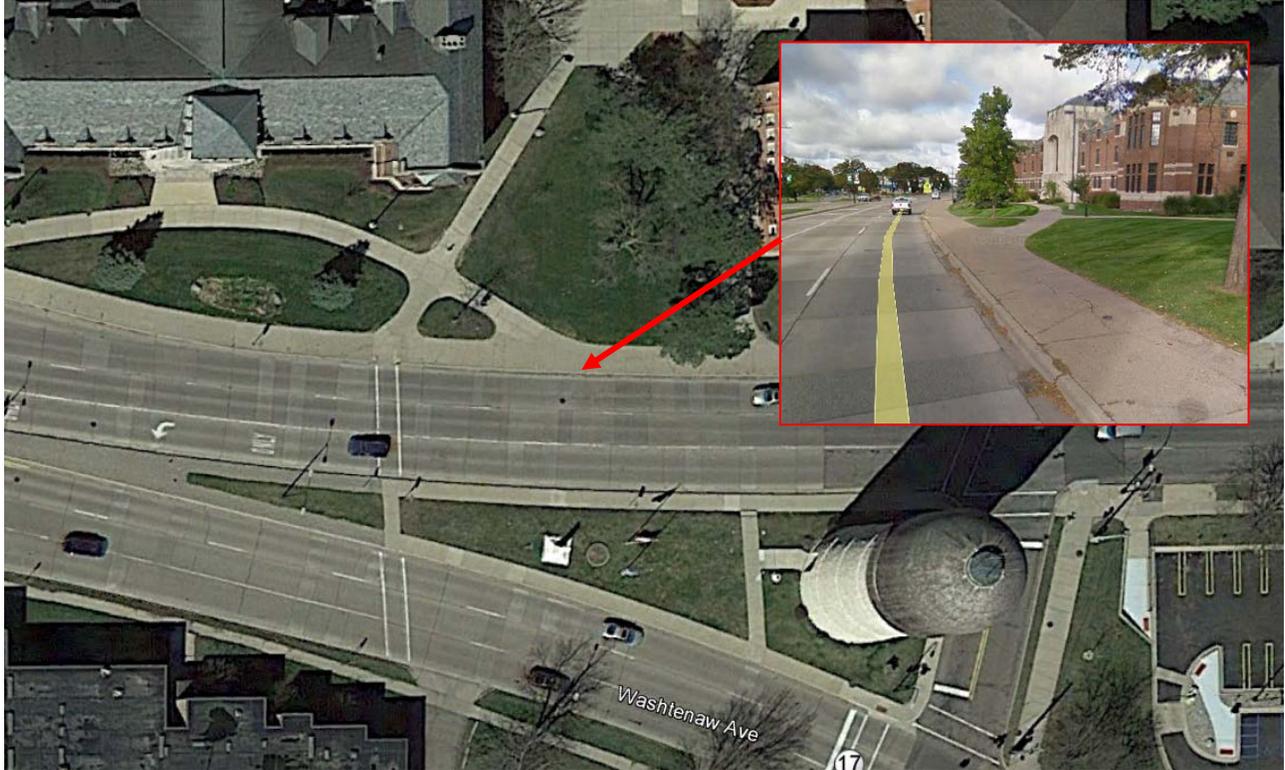
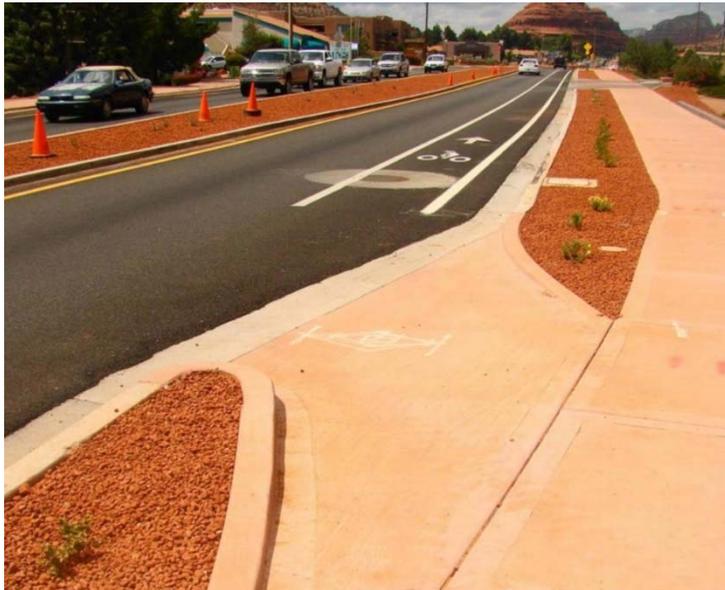
F.1. Option A – Install a Bike Lane Transition Ramp

Installing a bike lane transition ramp like the one pictured to the left would terminate the bike lane just west of the water tower and allow bicyclists to transition onto the sidewalk and into the Eastern Michigan University campus.

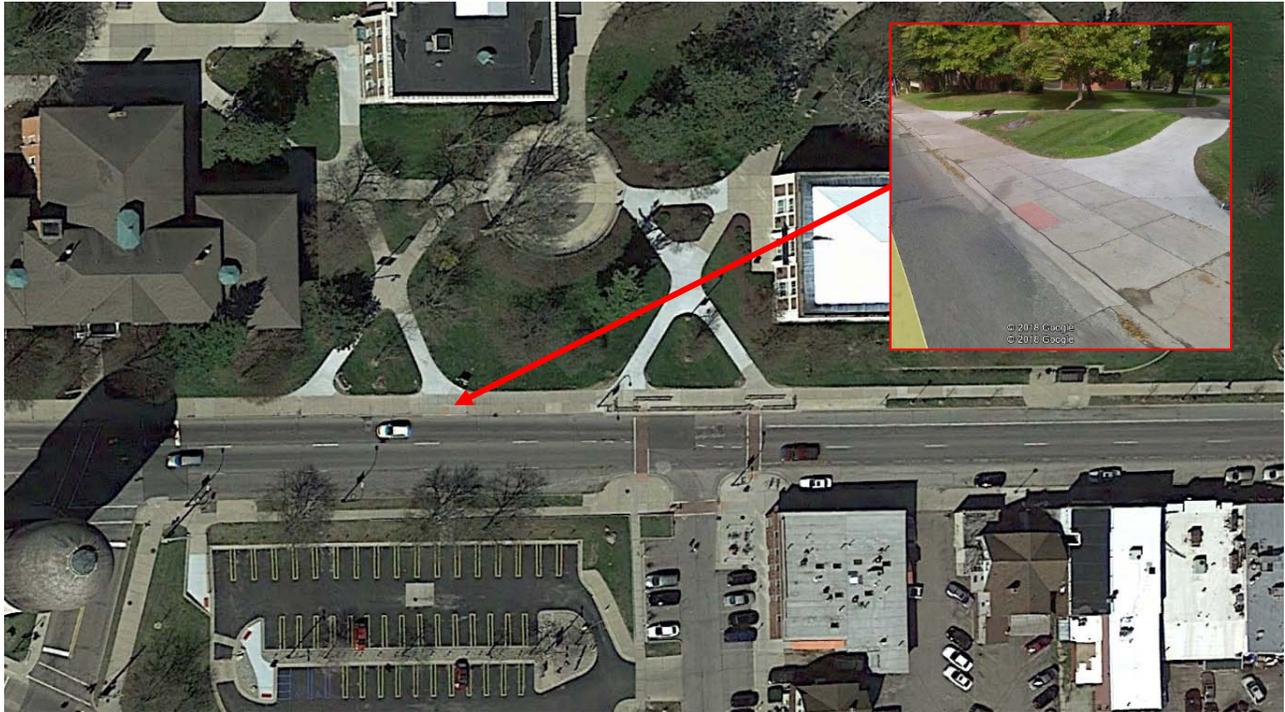
F.2. Option B – Utilize an Existing Ramp for Transition

This option would utilize an existing ramp just west of the existing termination point to allow bicyclist to transition onto the sidewalk and into campus.
