# Appendix I: Dam Removal Feasibility Study

# **PENINSULAR PAPER DAM: DAM REMOVAL ASSESSMENT AND FEASIBILITY REPORT**

## **HURON RIVER, WASHTENAW COUNTY, MICHIGAN**

**SEPTEMBER 2018**

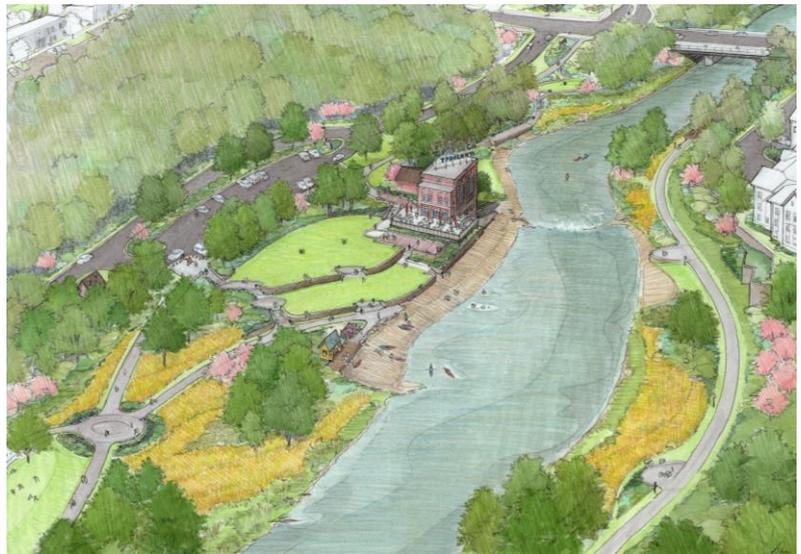
Figure 1. Artistic rendering of the vision for Peninsular Park with dam removal. (SmithGroup)

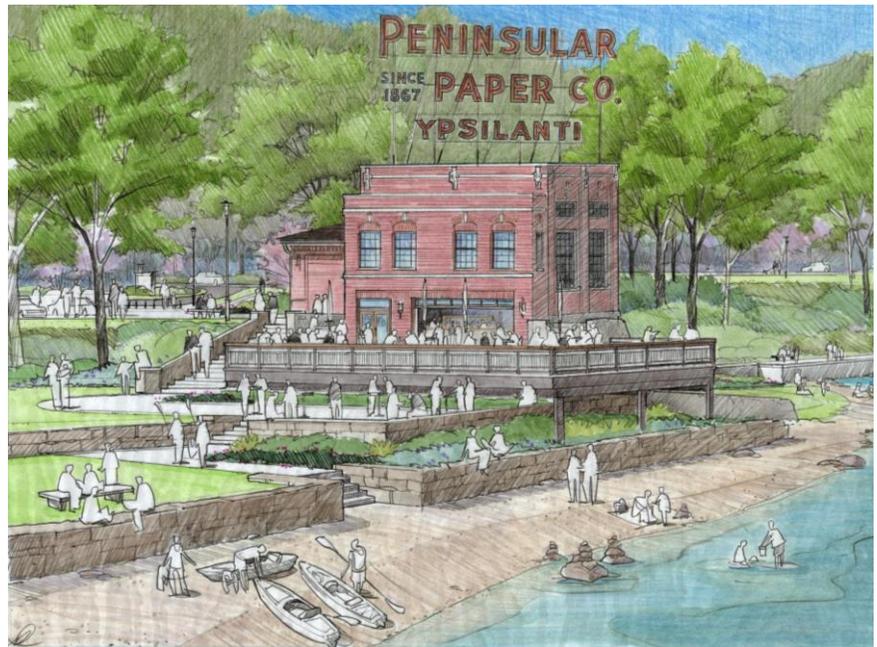
Figure 2. Artistic rendering of the vision for Peninsular Paper Dam Powerhouse with dam removal. (SmithGroup)

artistic rendering, completed by design firm SmithGroup, to illustrate the creation of floodplain re-utilized as public park land, as well as, the preservation and re-use of the iconic powerhouse.
